A CLOSER LOOK INSPECTIONS, LLC
112 Tranquil Lane
Ladson SC 29456
(843)607-8486
acloserlookinspections1@gmail.com

Client Information: Record Number 3691

Sample, S
Sample
Sample, SC

Inspected 8/20/22 1:00 PM

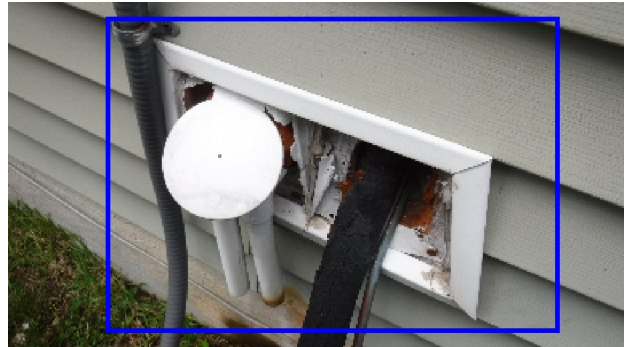
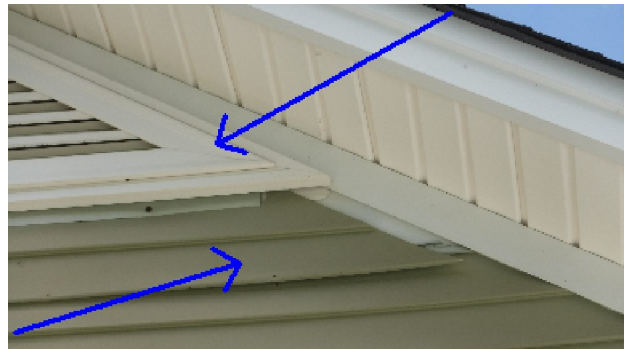
Siding

Section of siding is loose over front corner gable end louver garage; should be re fastened.
Right side cover over Freon/drain lines should be replaced.
Suggest further evaluation/repairs as needed@siding.

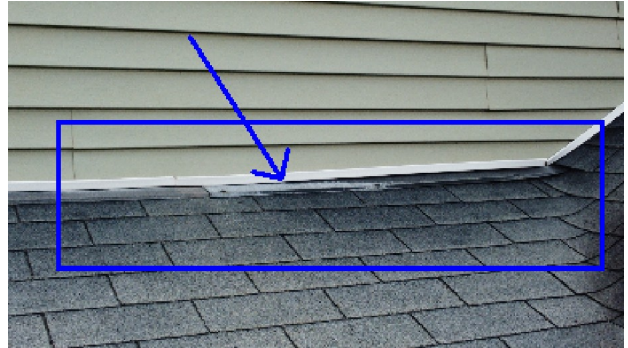
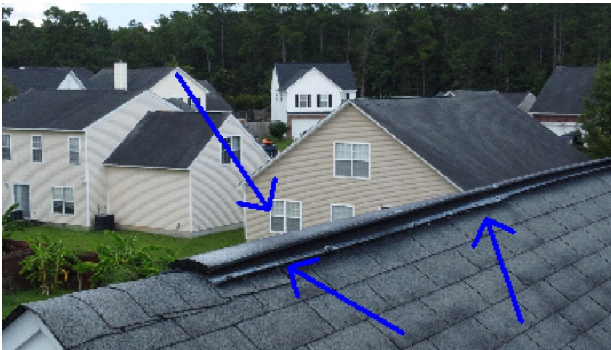
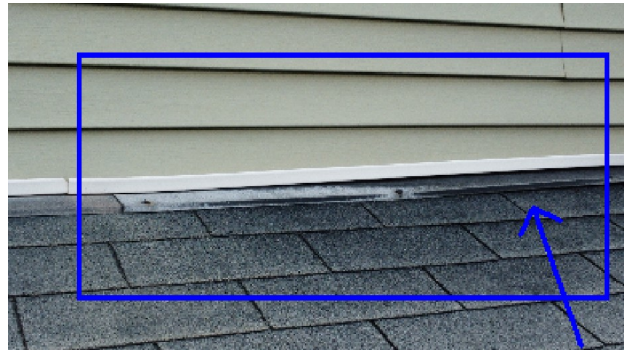
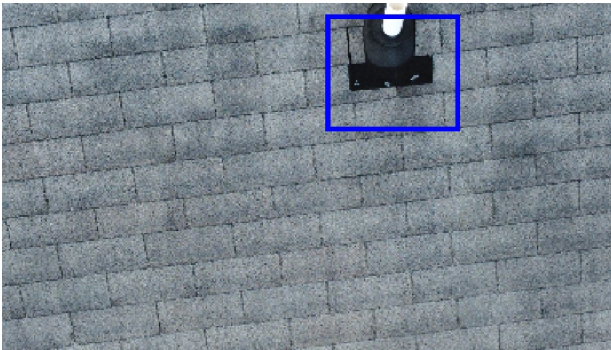
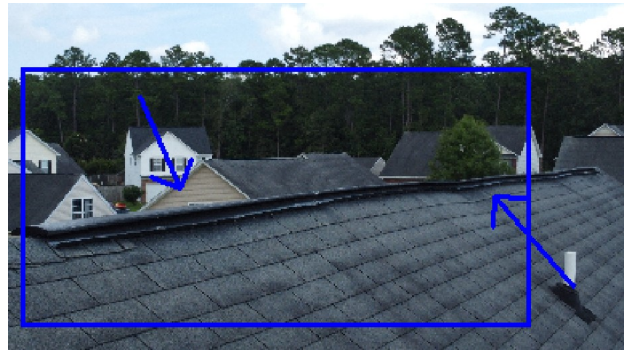
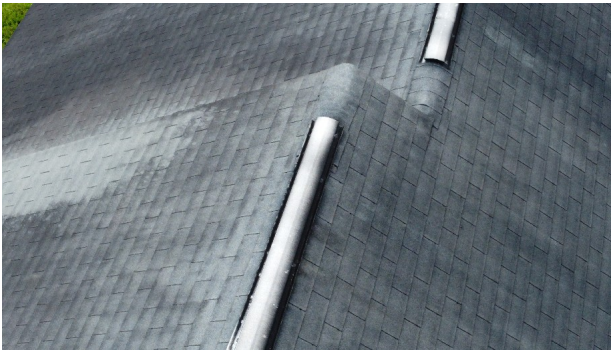
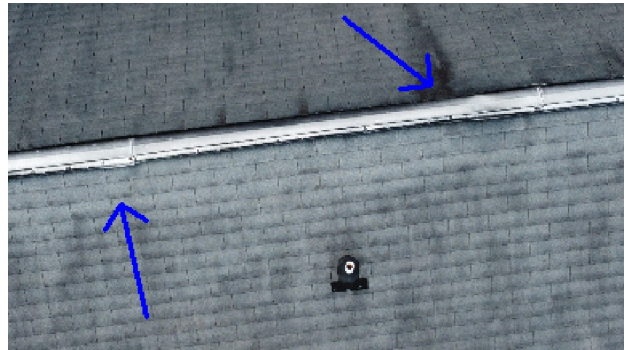
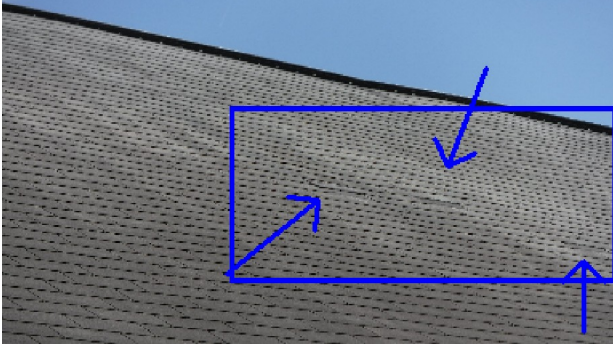
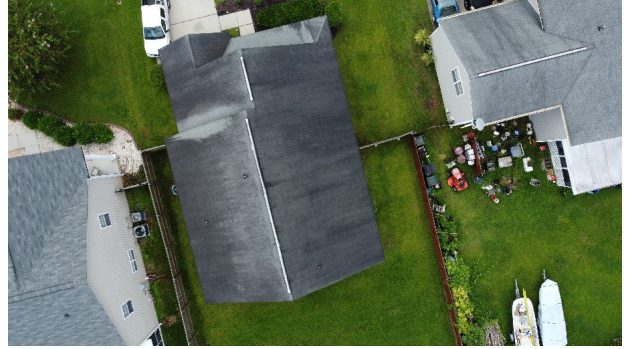
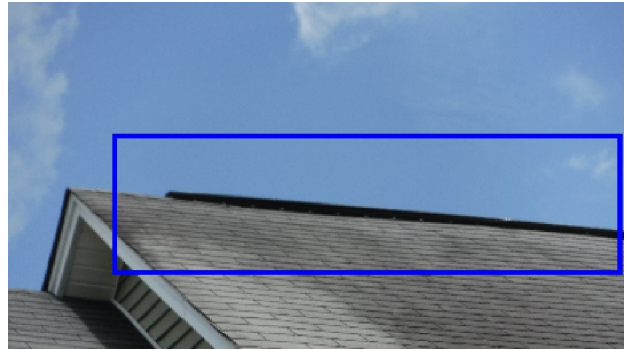
ROOF

Roof is about 14 yrs old with a 3 tab 20 year shingle. Normal wear noted. That being said some normal age related maintenance follow ups/ repairs needed @ the roof. Suggest the entire roofing system be evaluated & repairs made as needed by a licensed professional. Defects at the roofing shingles to include but not limited too: shingles are chipped, broken off at right side mid (should be replaced), upper front ridge vent is dented, dinged (a number of exposed nail heads noted/ tar, seal). Exposed nail heads should be tarred and sealed @ the front porch flashing. Several nails have worked their way loose @ flashing. Repairs needed.

Roof is about 14 yrs old with a 3 tab 20 year shingle.
Normal wear noted. That being said some normal age related maintenance follow ups/ repairs needed @ the roof.
Suggest the entire roofing system be evaluated & repairs made as needed by a licensed professional. Defects at the roofing shingles to include but not limited too: shingles are chipped, broken off at right side mid (should be replaced), upper front ridge vent is dented, dinged (a number of exposed nail heads noted/ tar, seal). Exposed nail heads should be tarred and sealed @ the front porch flashing. Several nails have worked their way loose @ flashing. Repairs needed.

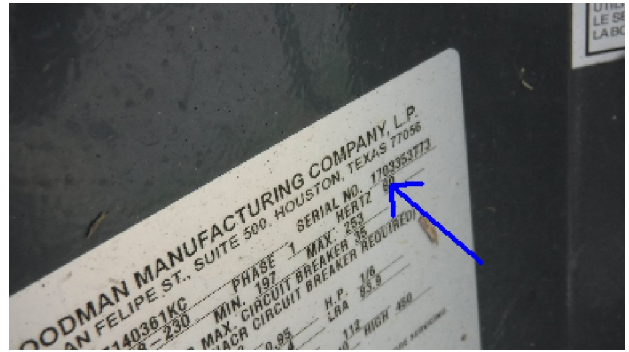
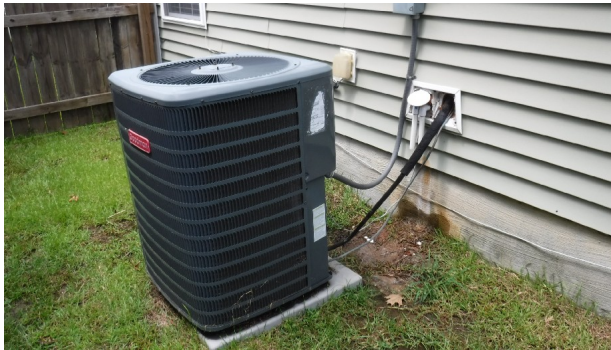
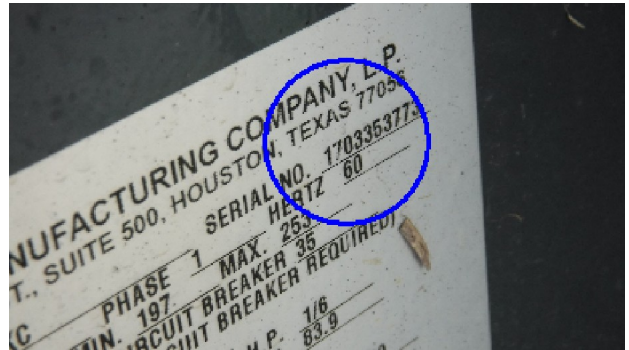
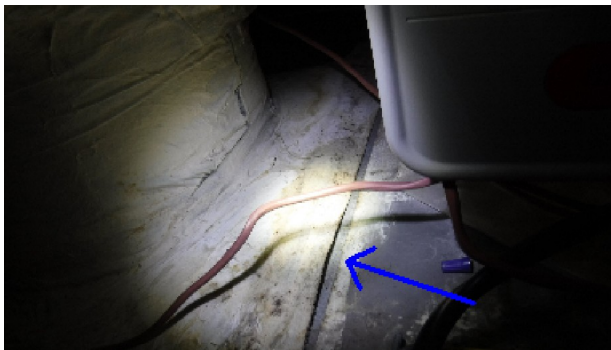
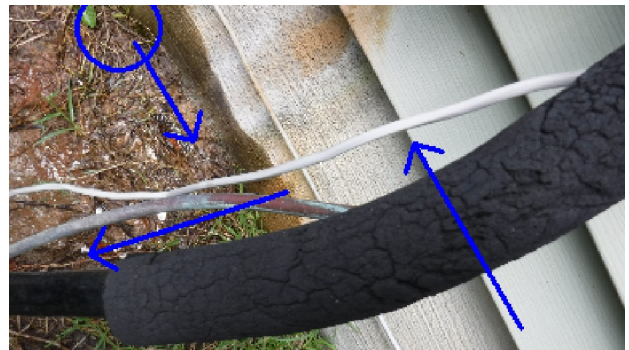
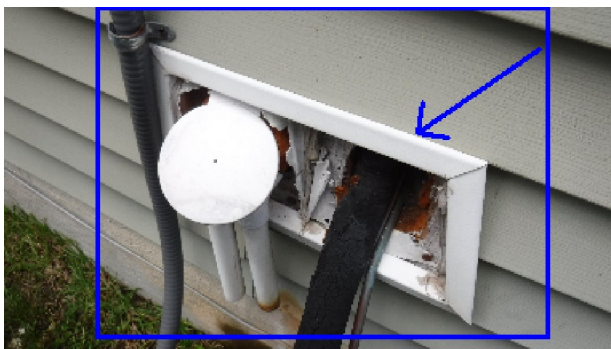
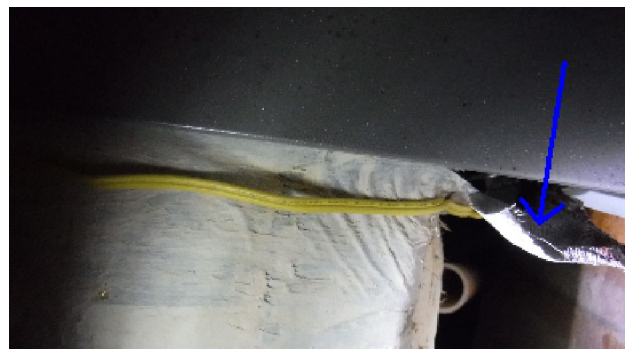
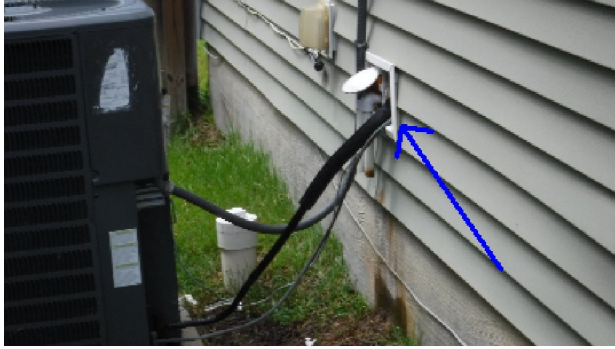
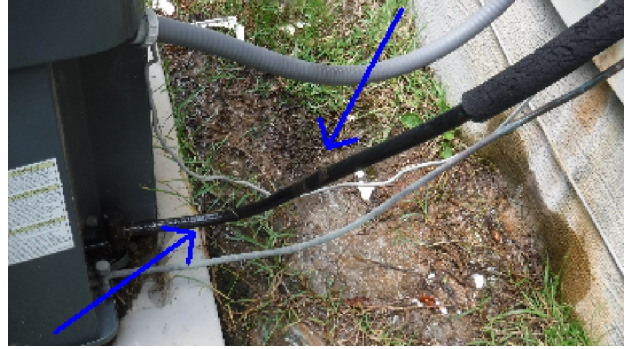
COOLING SYSTEM

Temperature differentials are low on the AC cooling. Recommend service, evaluation & freon charge prior to closing.
Drain line at right side by compressor should be pushed away from the home. Standing water noted by compressor at yard from a good bit of water coming off unit. Add some sort of tubing.
Wire at compressor should be in conduit. Cover over Freon/drain lines (vinyl) should be put back in place. Has broken off.
Freon line insulation is torn/ missing; suggest replacing.
Ductwork trunk line in attic by air handler needs to be resealed/ re taped.

Temperature differentials are low on the AC cooling. Recommend service, evaluation & freon charge prior to closing. Drain line at right side by compressor should be pushed away from the home. Standing water noted by compressor at yard from a good bit of water coming off unit. Add some sort of tubing. Wire at compressor should be in conduit. Cover over Freon/drain lines (vinyl) should be put back in place. Has broken off. Freon line insulation is torn/ missing; suggest replacing. Ductwork trunk line in attic by air handler needs to be resealed/ re taped.

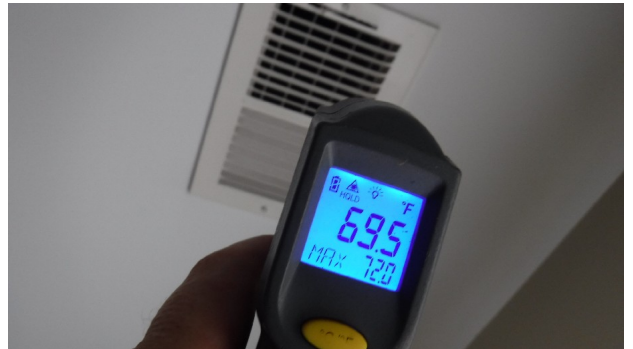
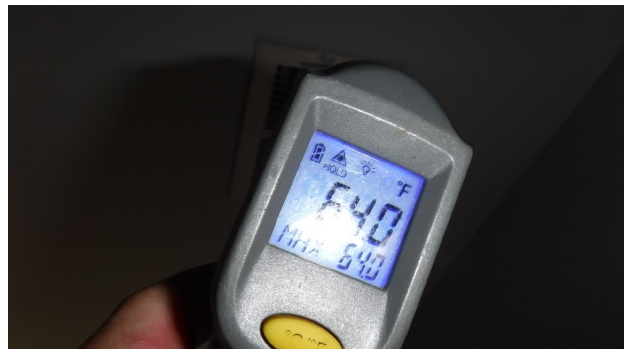
Differential Temp 1

Return temp = 74 Supply temp = 69-64 Differential Temp = 5-10
Temperature differentials are slightly low on AC cooling. Suggest evaluation, service & freon charge prior to closing.
Zone thermostat controls 1 upstairs, 1 downstairs operational.

Return temp = 74 Supply temp = 69-64 Differential Temp =5- 10
Temperature differentials are slightly low on AC cooling. Suggest evaluation, service & freon charge prior to closing. Zone thermostat controls 1 upstairs, 1 downstairs operational.

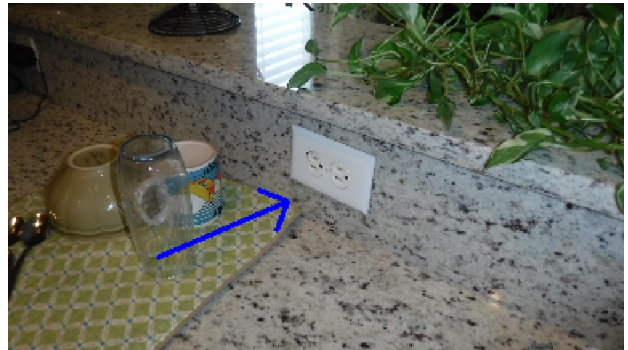
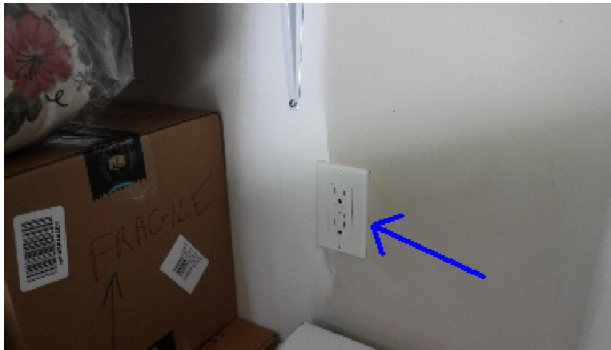
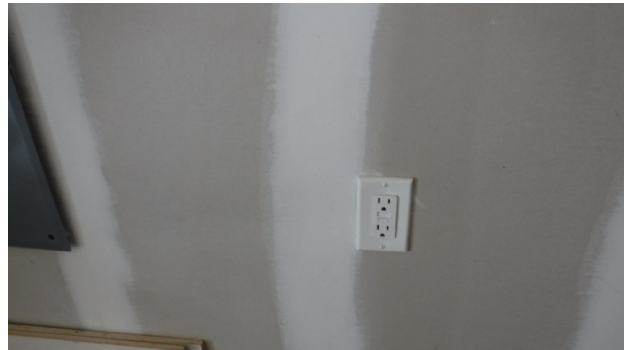
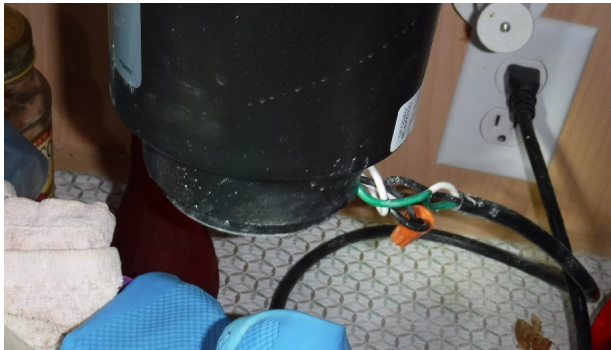
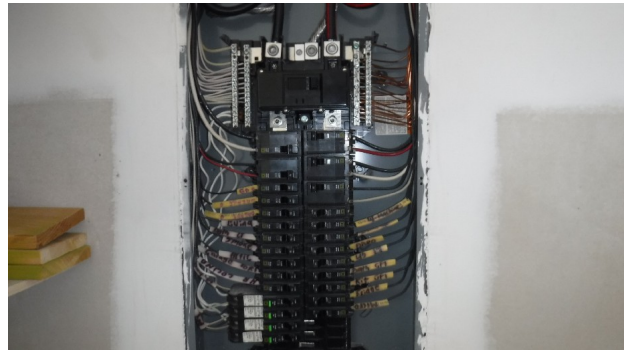
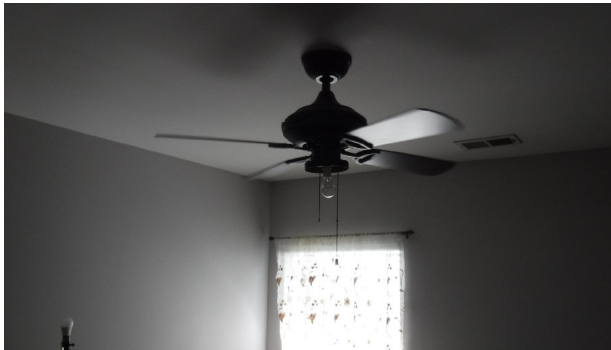
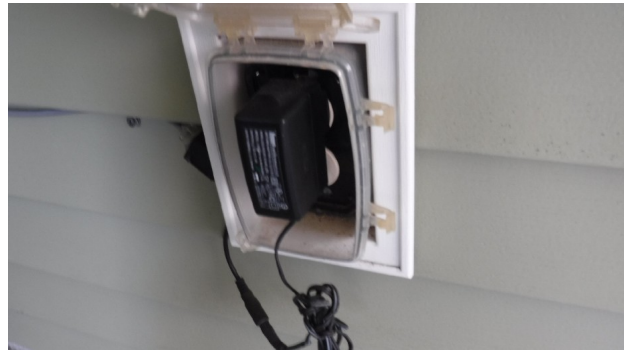
ELECTRICAL SYSTEM

200 amp under ground service noted. Minimal electrical defects noted to conditions observed.

Picture of panel box with cover removed.

GFCI reset rear garage for exteriors, hall bath for bathrooms.

Several loose receptacles at kitchen sink, exteriors. Should be resecured.

Wire splices underneath the sink at disposal should be placed into disposal.

Lens cover is missing at right side mid bedroom ceiling fan.

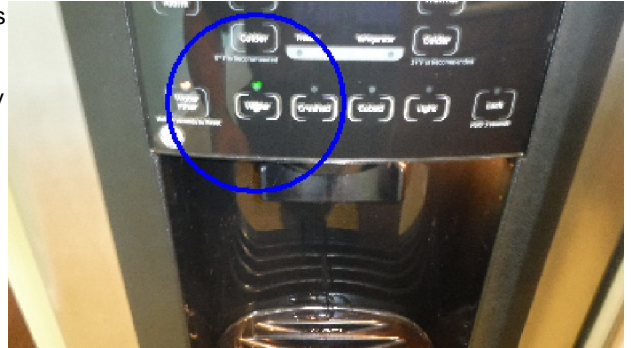
KITCHEN

Several upgrades noted in the kitchen to include: Granite countertops & energy efficient appliances
Most appliances are operational at the time of the inspection.
Water dispenser at the refrigerator is not working. Control button may be massed up.

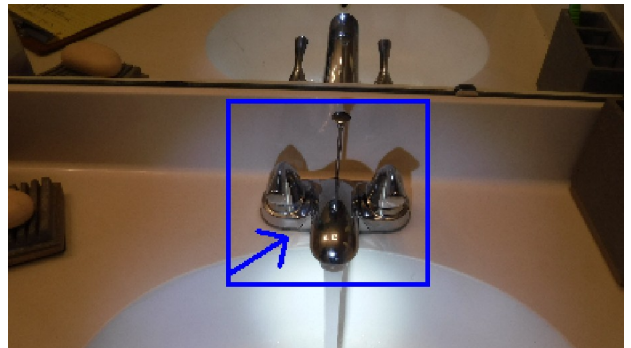
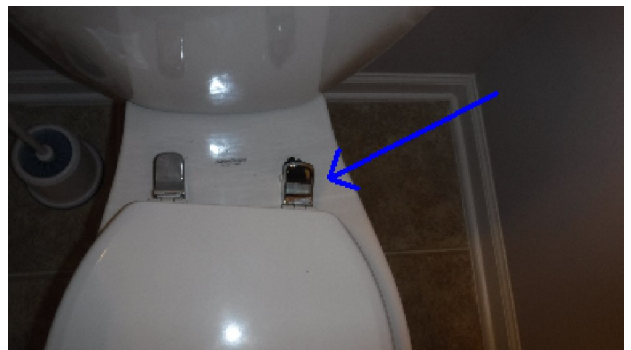
BATHROOM

Ran bathroom plumbing 10 minutes
Right side master bath vanity sink control atop sink (slight leaks where meet the sink). Suggest resetting, making leakfree prior to closing.
Toilet seat cover is loose. Should be properly refastened.

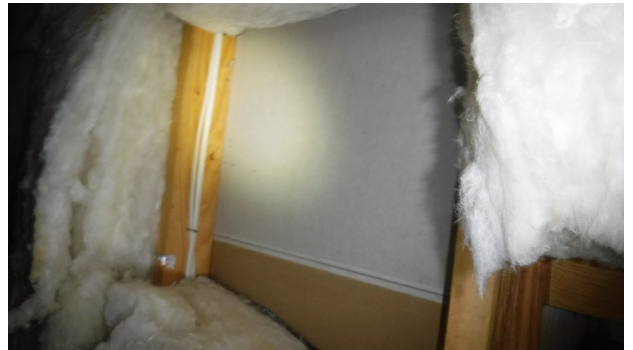
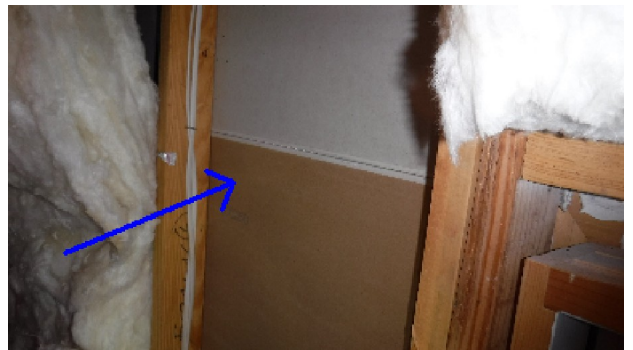
Attic Insulation Approx. R. Value

Insulation should be rehung @ the attic entry wall. Few sections have come loose. Should be refastened.

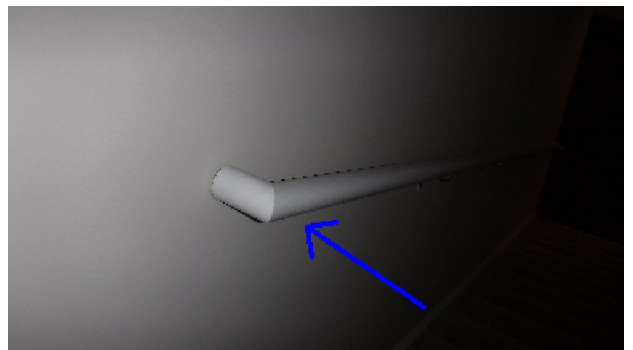
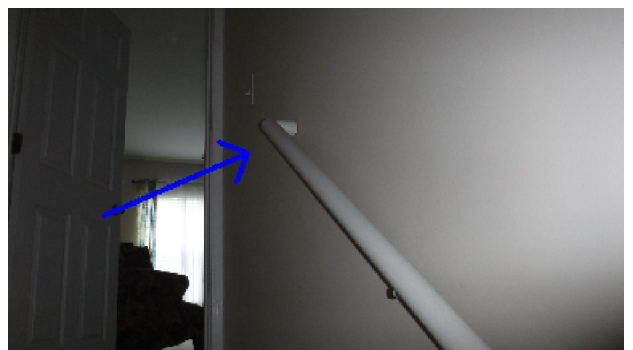
Stairways

Upper handrail is loose at stairs. Should be refastened/secured.

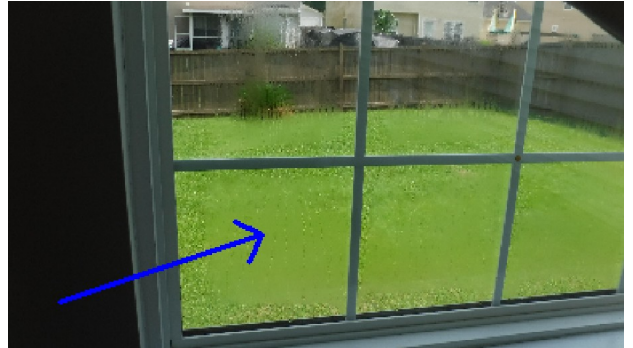
Window Character Type

Other =Single hung
Cannot be 100% certain glass is condensated at several windows until cleaned; do not think they are or if they are condensation is minimal.
Master bathroom window by the tub is condensated.
FYI- Generally glass condensation @ windows is considered a cosmetic issue & will not be covered in home repairs.

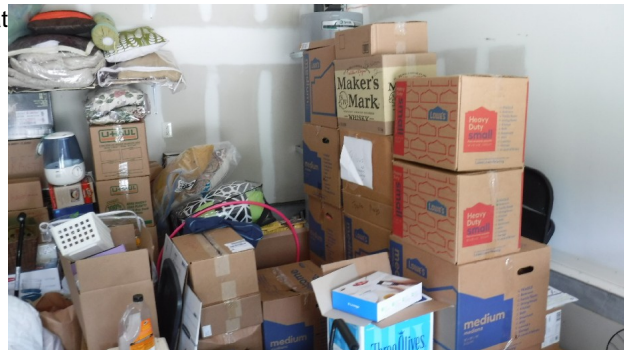
GARAGE

Stuff in garage makes areas inaccessible. In the process of moving at this time.
