Inspected 9/20/22 1:30 PM

Inspection Summary

A CLOSER LOOK INSPECTIONS, LLC

Record 3719 - Sample, S Sample, Sample, SC

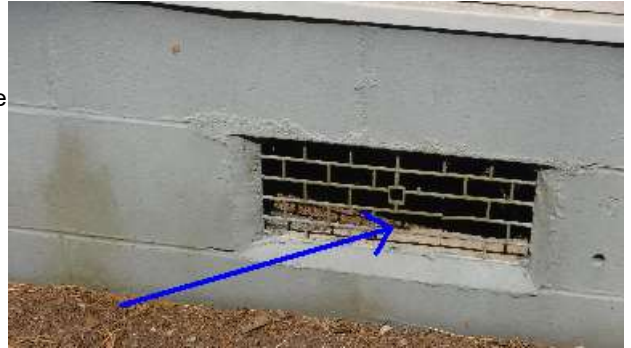
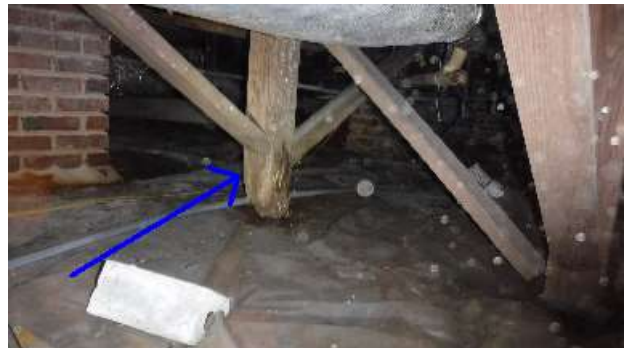
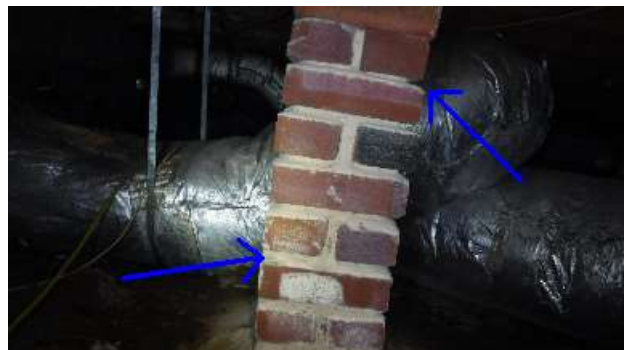
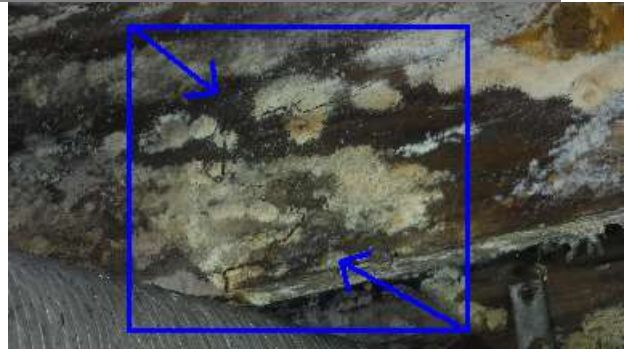
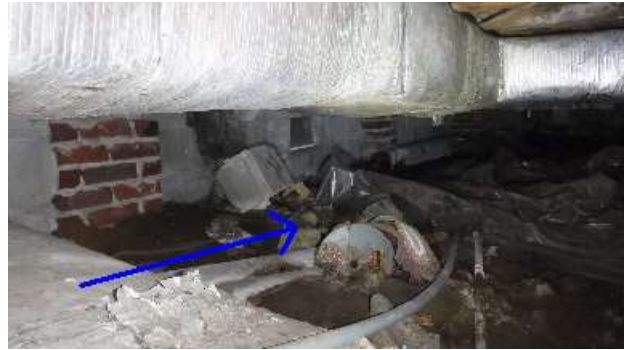
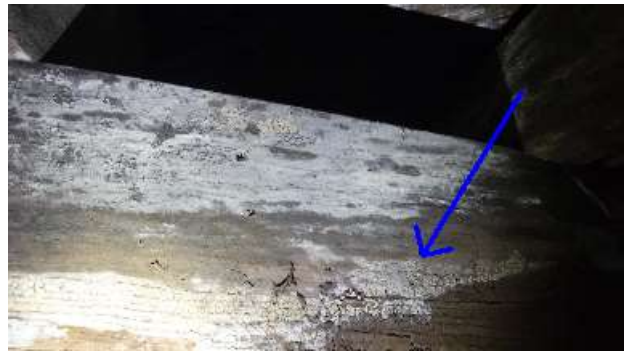
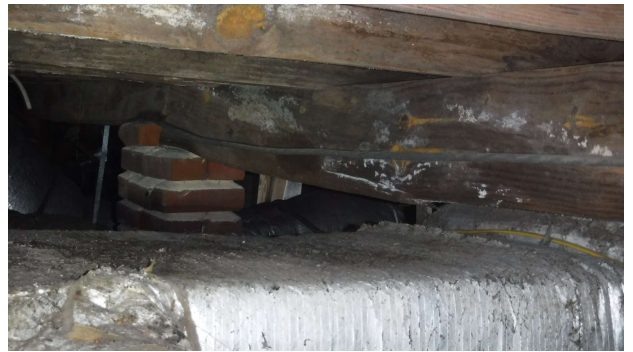
CRAWL SPACE

Middle girder beams (under the living room; settlement issues noted at flooring in this room) compression noted on top of piers. Girders are bowed/warped (possibly cracked) on top of these piers. Right side mid several bricks missing @ piers. Right side mid cracked more joists noted. Sister joists, additional supports needed. Cubicle Brown dry rot noted at mid crawl from elevated moisture coming off ductwork. Several areas of repairs have been completed under kitchen and areas.

Cut joist under the bath, suggest additional supports. Right side under kitchen additional supports of been added. 6 x 6 pressure-treated piers. Suggest replacing with possibly concrete piers and supports at some point

Some mortar is thin/ missing @ brick piers; suggest adding as needed.

Moisture stains under baths, kitchens (some repairs made under kitchen). Mildew, elevated moisture levels fungi, potential mold under mid flooring system (cannot determine unless tested on flooring system throughout). Suggest spraying with fungi/ Bora Clean. Often Termite companies will off this service.

Suggest sealing crawlspace vents to keep rodents out of crawl. Debris in crawl should be removed.

See CL100 remarks. Recommend a licensed contractor evaluate these areas, the entire crawlspace & make repairs as needed prior to closing.

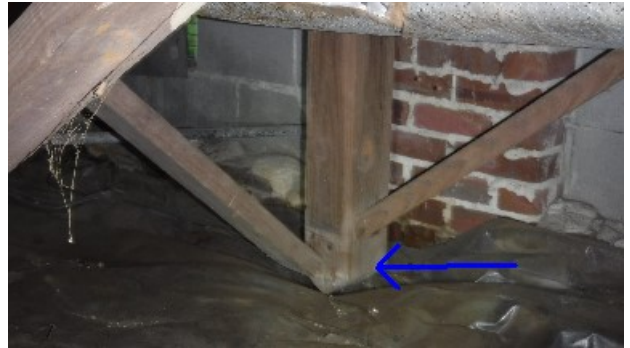
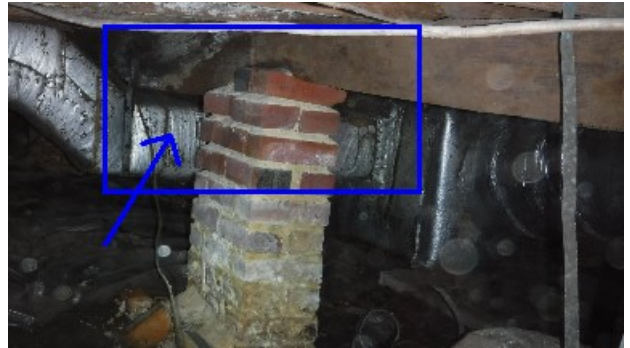
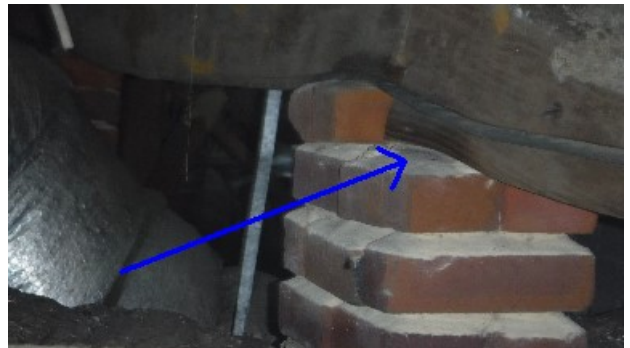
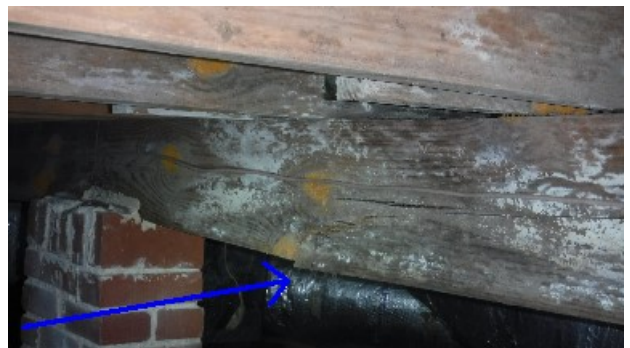
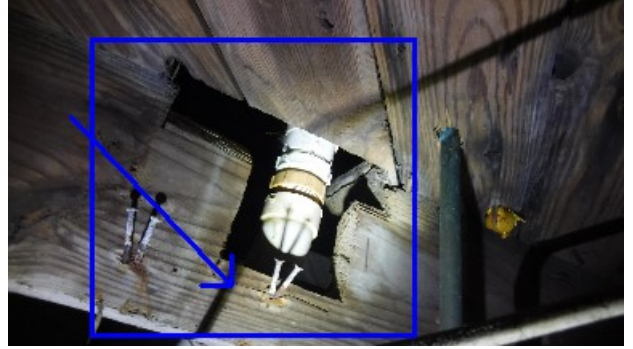
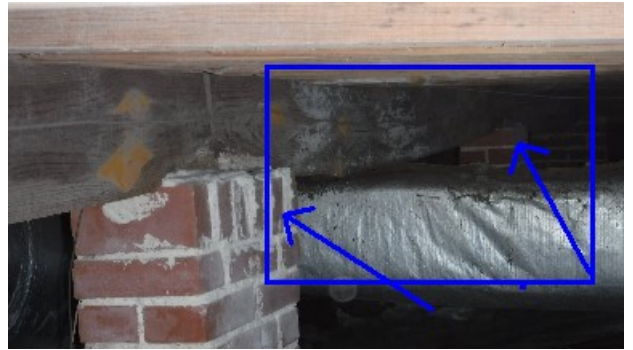
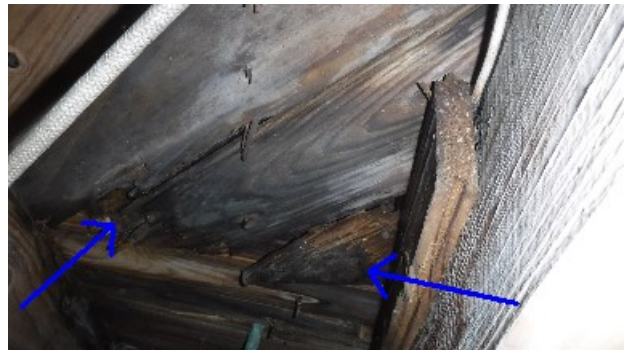
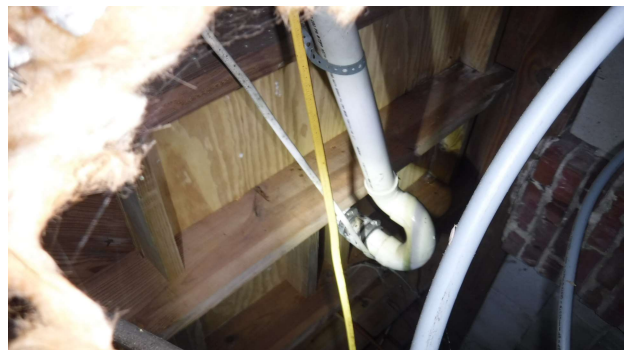
Crawl Space Type

More crawlspace discrepancies / pictures as follows.

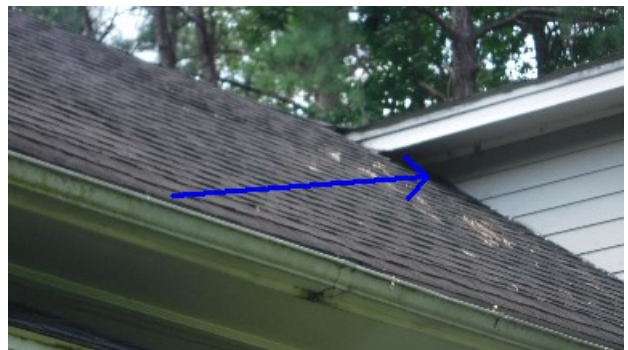
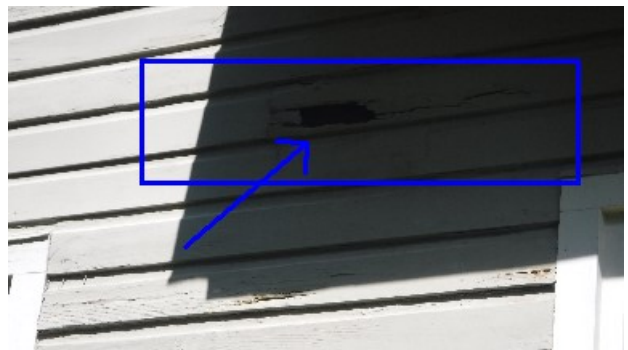
EXTERIOR

Exteriors have been painted making wood damages more difficult to spot. See CL 100 remarks. Suggest all exteriors wood trim "windows, soffit's/ fascia" be evaluated/ repairs made as needed by qualified contractors. Wood damages appear to be normal age-related type conditions. Exterior wood will require ongoing maintenance. For the age of this house very normal conditions. Wood damages to include, but not limited too: right side rear soffit corner, rear right upper where roof ties in to siding, upper right toward Gable where siding meets roof, right side front porch corner outer under gutter, left side mid "front behind bush", left side rear above window & areas. Paint is chipped/ peeling at few areas. Most likely/ good chance paint is lead based paint. Should not be ingested by children or pets. Trees & shrubs should be cut away from the home as needed. Should be roughly 8"-12" between siding & home.

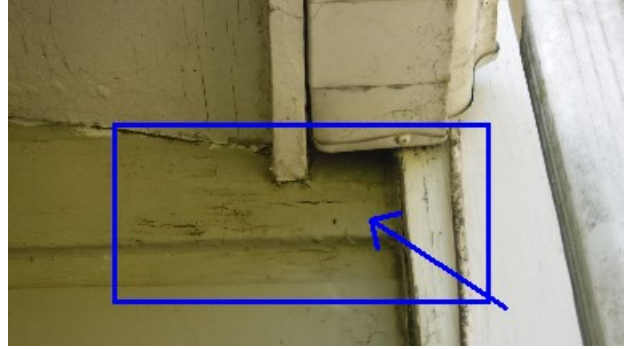
Soffit\Fascia

Some loose paint and wood rot noted. Suggest soffit vents suggested every 10' & @ corners. Only issue with this home is if vents were added the air flow generally would not get into the attic. Believe these soffit are covered over by attic flooring which would obstruct air flow into attic's. Additional vents would be some help in our professional opinion. More air flow going into this ventilation system the less chances of rot, damages.

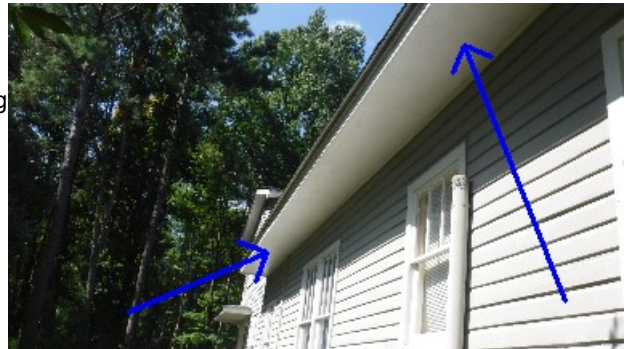
Siding

Several areas of wood siding damages noted. Suggest evaluation/ repairs made as needed at all exterior siding/ trim by a licensed professional prior to closing.

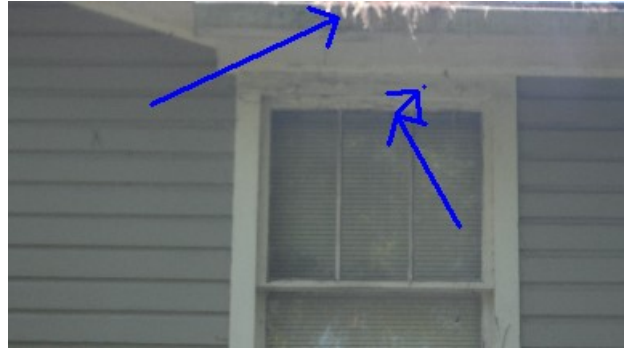
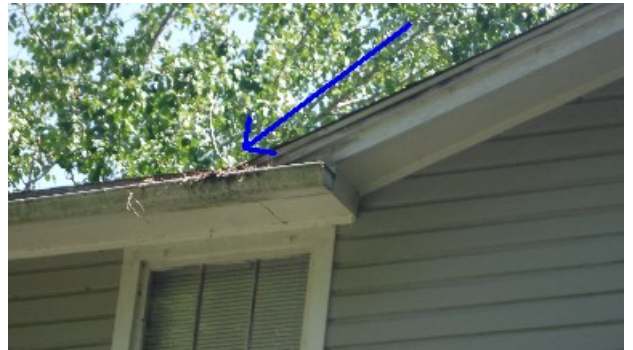
GUTTER SYSTEM

Gutters should be cleaned full of leaves/ debris.

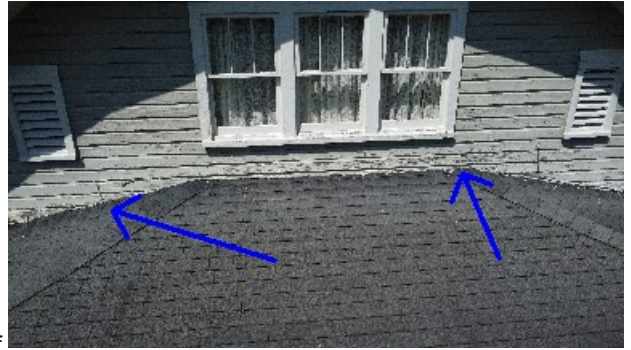
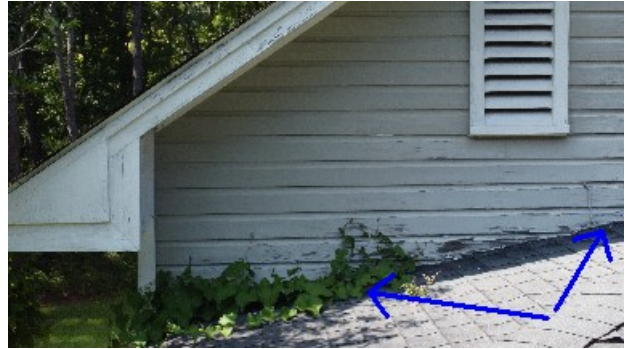
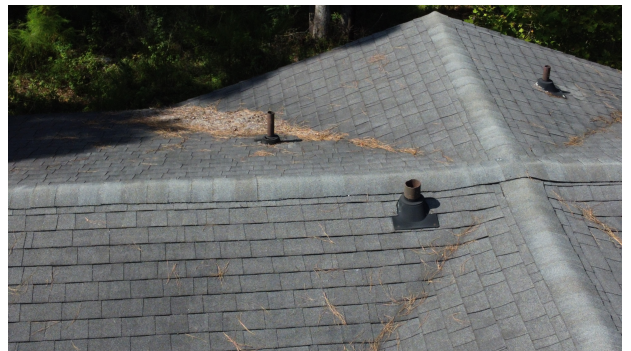
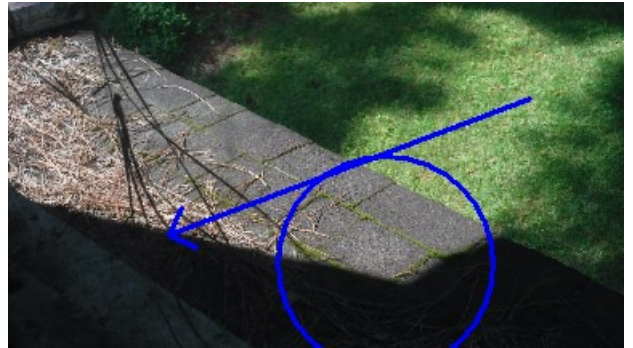
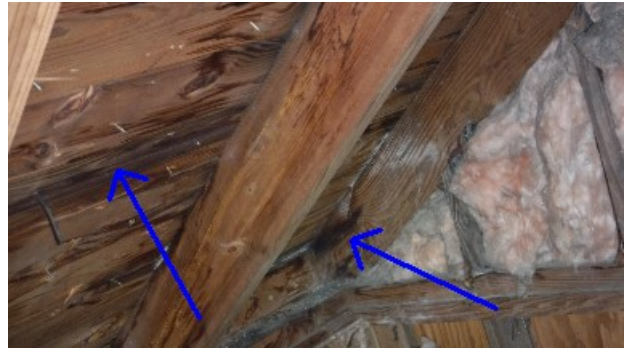
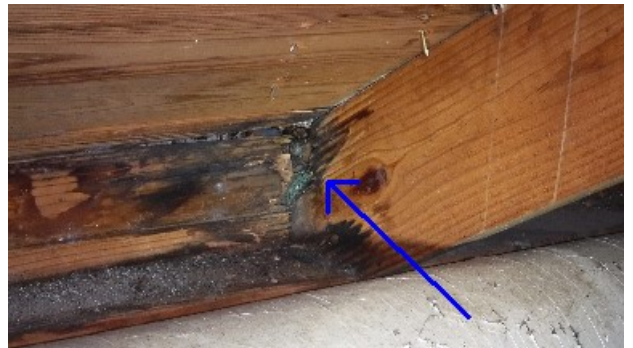
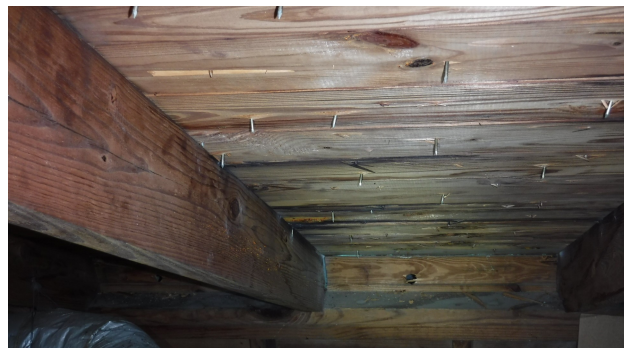
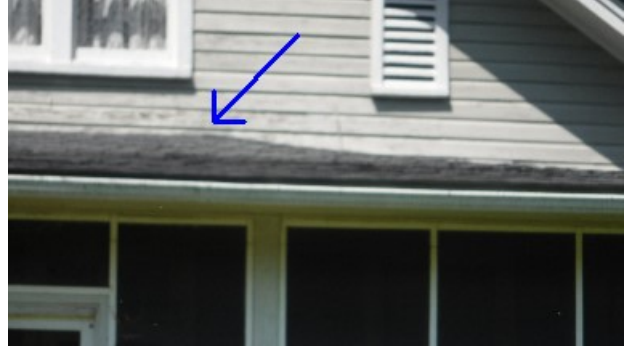
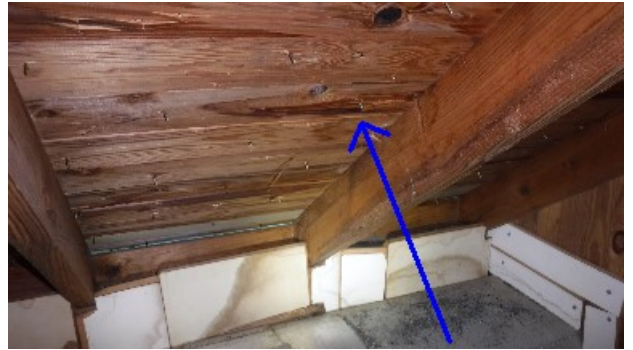
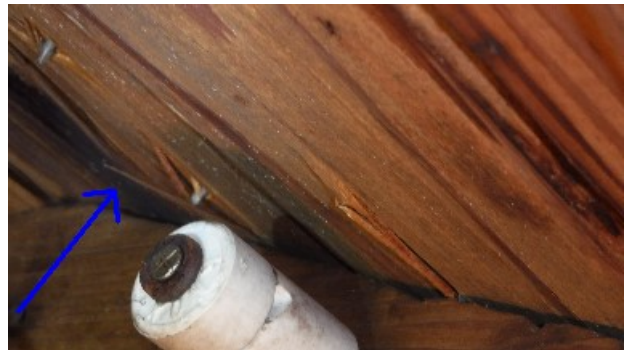
ROOF

Roof is roughly 20 yrs old with a 25-30 year architectural shingle. Several rear outer lower perimeter lower shingles are chipped, mildew/moss growing on them.

Pine straw and leaf foliage should be removed from shingles as needed. Foliage will prematurely damage/ age shingles "chemical compound".

Several moisture stains noted in attics (rear left, rear right, right mid and areas). Appears to be slight leaks. Difficult to be certain exactly where leaks are coming from.

Several exposed nail heads/ nails worked their way loose @ areas of flashings. Suggest renailling/ tarring & sealing as needed.

Suggest adding step/counter flashing where siding meets the roof. Some areas of rear flashing suggest renailling tarring and sealing as needed.

Suggest evaluation/ repairs as needed at the roofing entire roofing system by a licensed professional prior to closing.

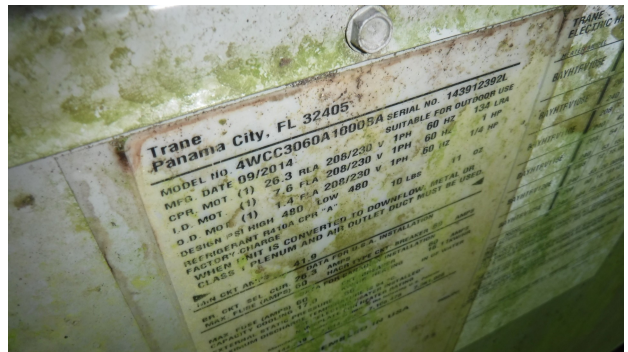
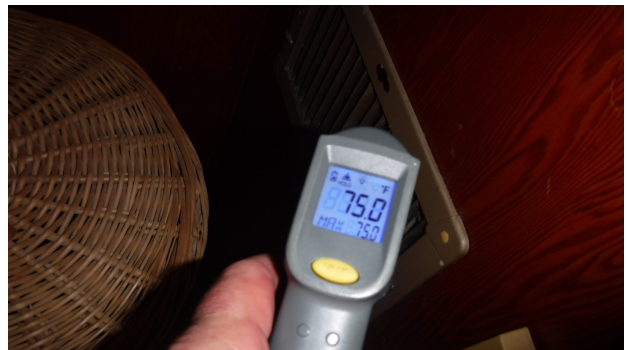
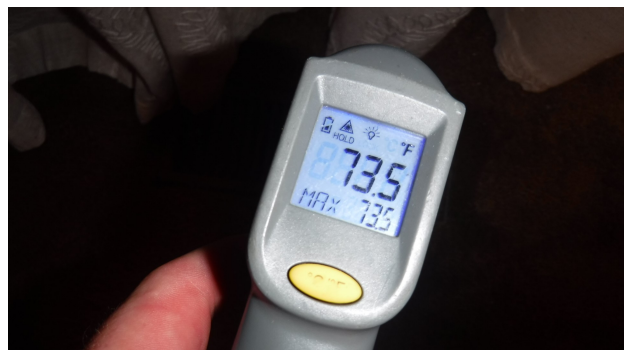
Differential Temp 1

Return temp = 80 Supply temp = 73-75 Differential Temp = 7-5

Temperature are low on AC cooling. Suggest evaluation, service & freon charge prior to closing.

Temperature differentials are low on the AC cooling. Recommend service, evaluation & freon charge prior to closing. Recommend evaluation/ repairs as needed by a licensed HVAC professional prior to closing.

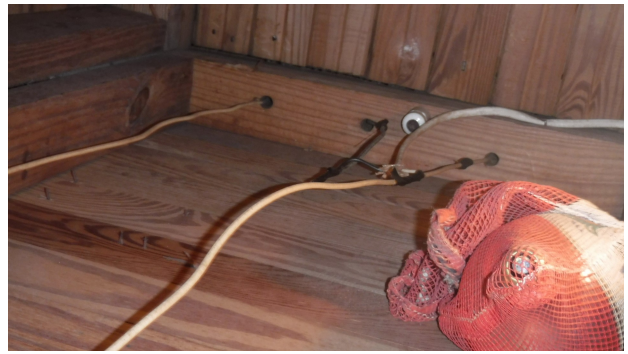
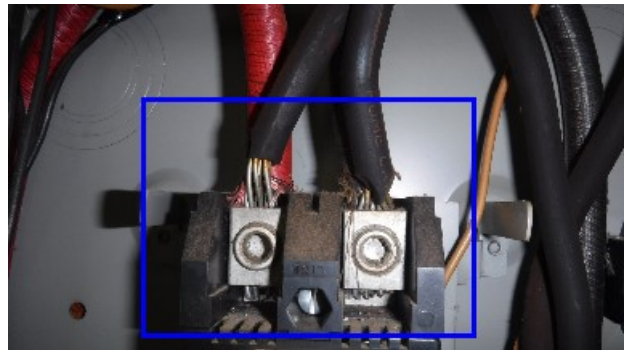
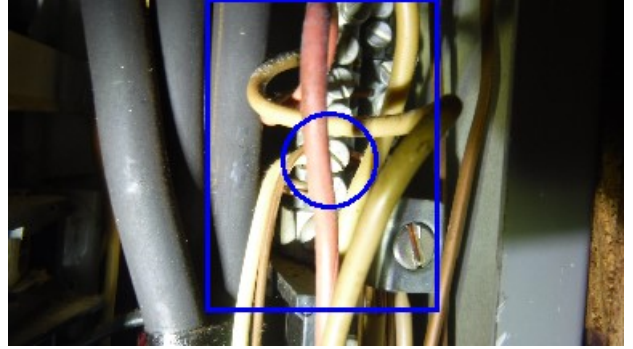
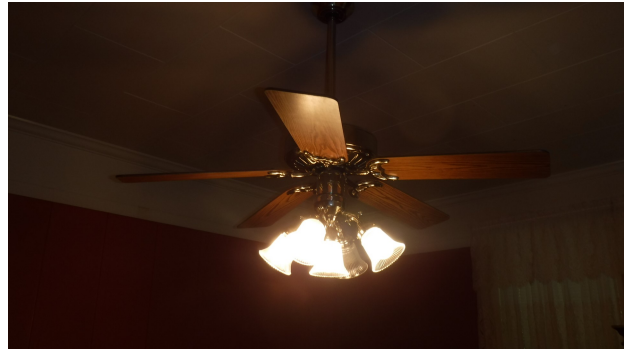
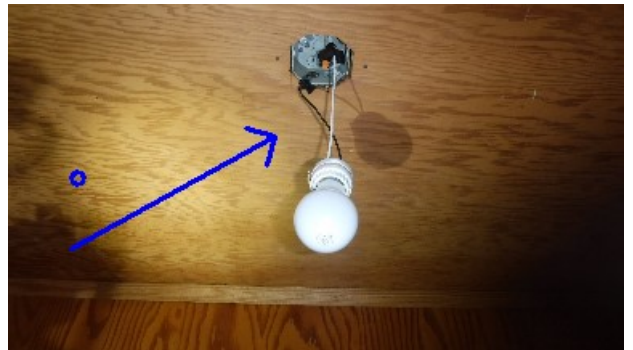
ELECTRICAL SYSTEM

Several electrical defects noted. Suggest the entire electrical system be evaluated by a qualified contractor and repairs made as needed. Defects include but are not limited too: 2 wires incoming into service main panel box. Additional wire added needs to be on its own dedicated breaker. As is could be a potential shock, fire hazard. Repairs needed.

Knob and tube wiring noted in home at areas throughout. Some appears to be still working in combination with other added wires. Will need to be further evaluated by an electrical contractor and repairs made as needed.

Neutral & ground wires directly on same screws on bus bar (normal building practice when home was built). Not recommended by today's standards. A number of ungrounded 3 prong receptacles throughout; should be grounded.

Service main water slightly close to ground. Will need to be conscious of this large say dump trucks are coming into yard. Upper bath receptacle is not working.

Several wire splices in crawlspace mid, rear should be placed in junction boxes. Some wires in attic "frayed/ worn coverings @ joists; no visible exposed live wires noted, fairly common in a home of this age".

Screws at panel box need to be replaced with flat/ non pointed screws.

Picture of panel box with cover removed.

Suggest placing all exterior, kitchen, bath & all wet location receptacles on GFCI's (FYI- since no GFCI's in home generally home owner is not obligated to upgrade to GFCI's, yet we still strongly suggest adding). Several light fixtures not working. Three way light switches are not working at living room, stairwell. Should be a light upon entering each room to include staircases.

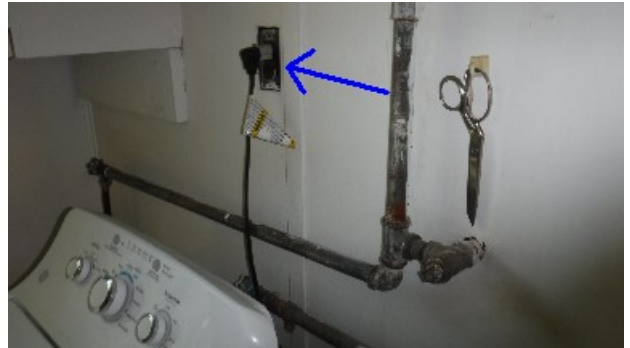
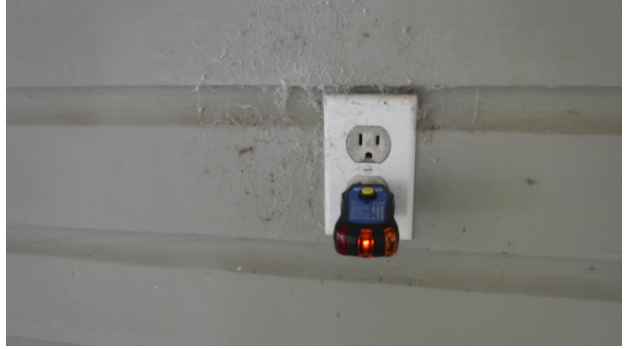
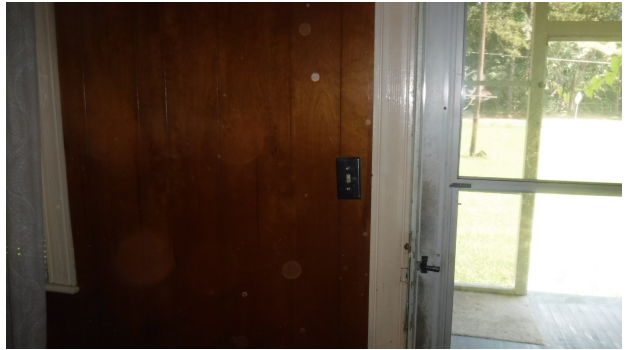
Main Electrical Service

More pictures of electrical defects continued.

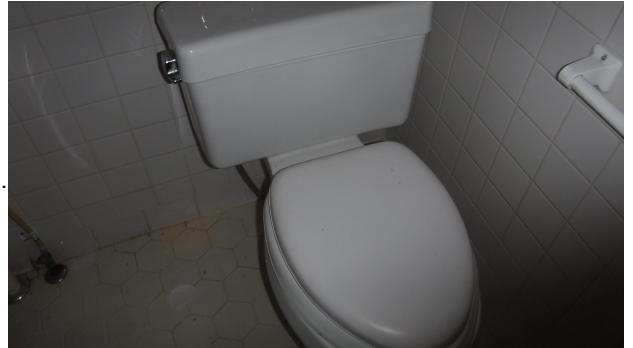
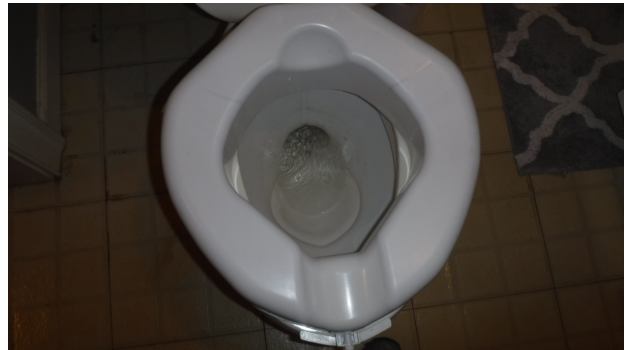
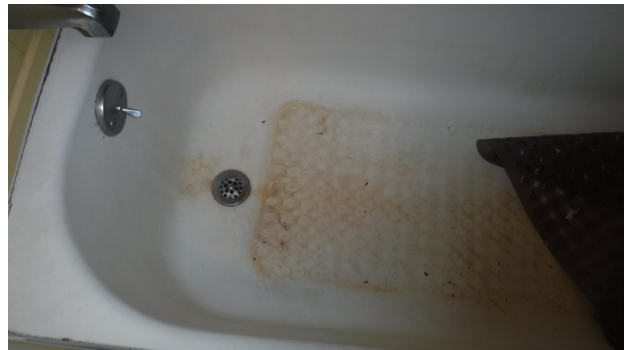
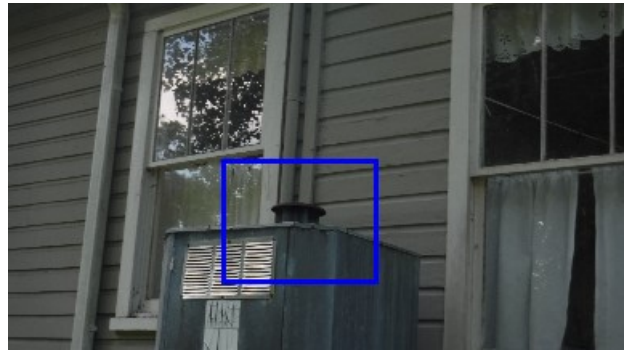
PLUMBING

Suggest running washing machine waterlines behind walls. Suggest raising plumbing off ground in crawlspace. Master bedroom toilet runs. Suggest replacing flapper hardware. Upper hall bath toilet is loose at ground. Suggest replacing wax seals. Gas water heater is not properly vented. Vent flues in close proximity to windows. Suggest properly venting gas water heater appliance. Shower faucet control is stripped. Upper bathtub rust/corrosion noted. Suggest properly caulking, sealing shower and tub surrounds. We recommend a licensed professional evaluate "ALL" plumbing & make repairs as needed.

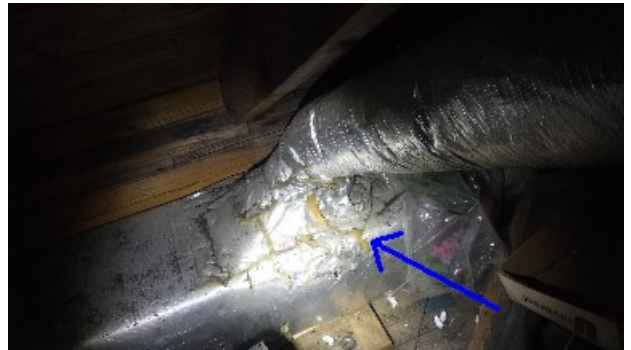
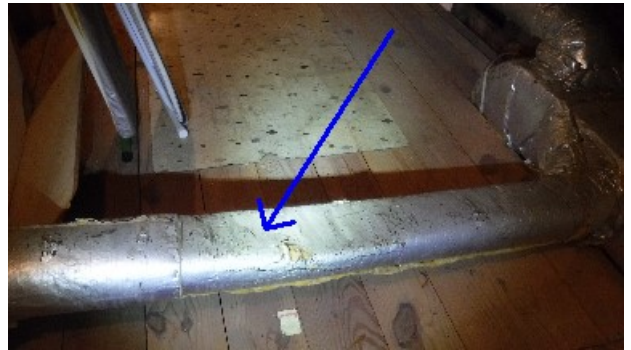
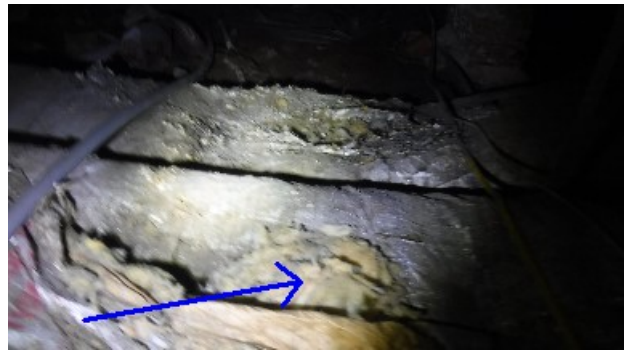
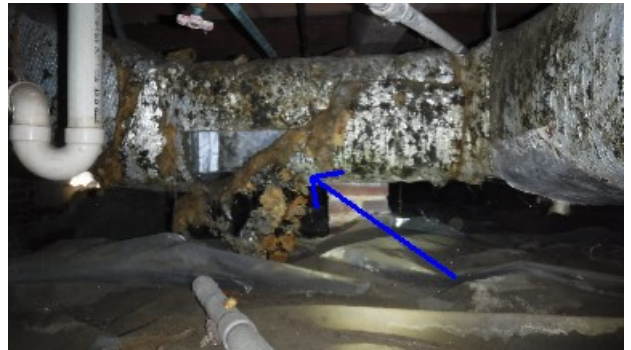
Distribution System Material

Sections of ductwork are poorly sealed, torn ductwork & should be resealed as needed in the crawlspace & attic's (right side attic mid ductwork mashed down). Several sections of ductwork may need to be replaced crawlspace due to rust and corrosion. Torn ductwork in the crawlspace has caused/ put a good amount of moisture into the flooring system.
Suggest evaluation at "ALL" ductwork & repairs made as needed prior to closing.

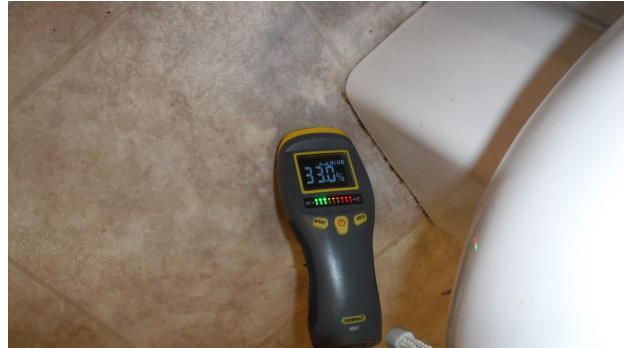
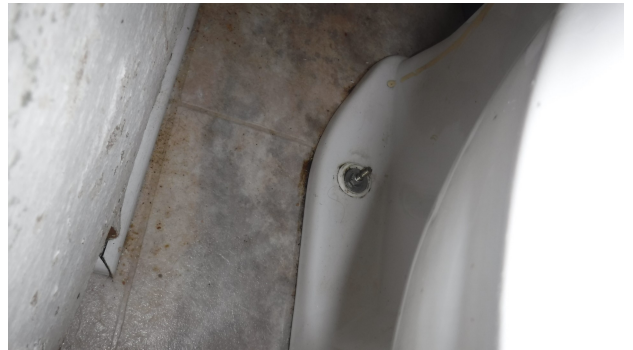
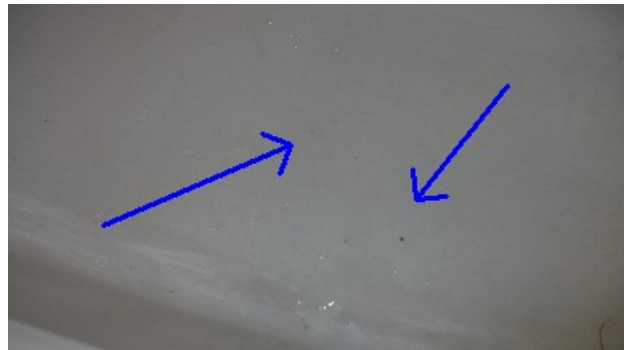
BATHROOM

See plumbing section on bath repairs.
Damaged flooring, elevated moisture levels under hall bath toilet.
Same bathroom window has been taped, towel added at lower sill.
Suggest making certain window properly sealed.
Slight chips noted at Hall bath tub. Suggest epoxy seal as needed.
Some cracked tiles, mortar thin @ areas of baths.

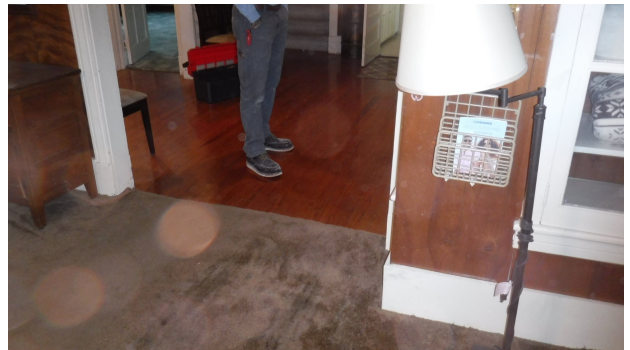
INTERIOR ROOMS

Flooring significantly dips/ settlement at living room, dining area. Appears to be from issues in crawlspace. Once these issues in crawl are addressed should take care of settlement.
Lead based paint more than likely at areas of trim throughout. Chips should not be ingested by children/pets. Suggest further evaluation, removal if concerned.
Carpets are stained at several areas throughout.

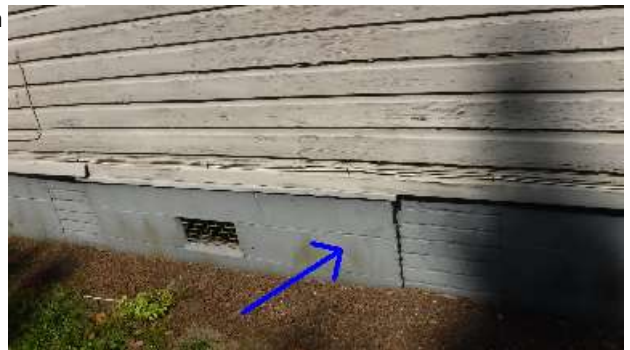
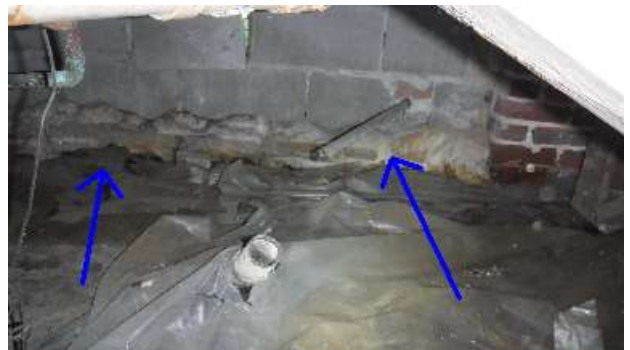
Exposed Foundation

Home appears to be balloon/ spot pier framing (possibly no footers in place at added lower block crawlspace enclosure). This was the norm & an acceptable building practice when this home was built.
Lower left side foundation blocks not levels slightly pushed out. Will need to monitor this and make repairs if conditions worsen.

Lower left side foundation blocks not levels slightly pushed out. Will need to monitor this and make repairs if conditions worsen.

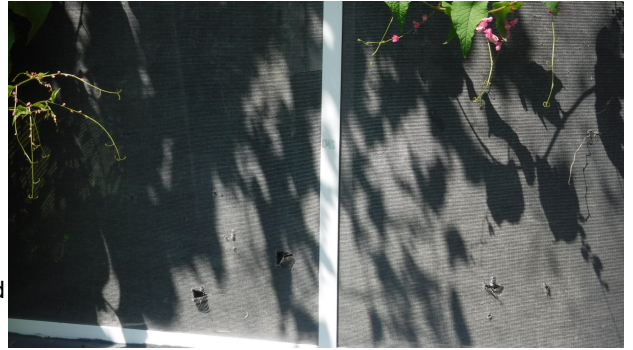
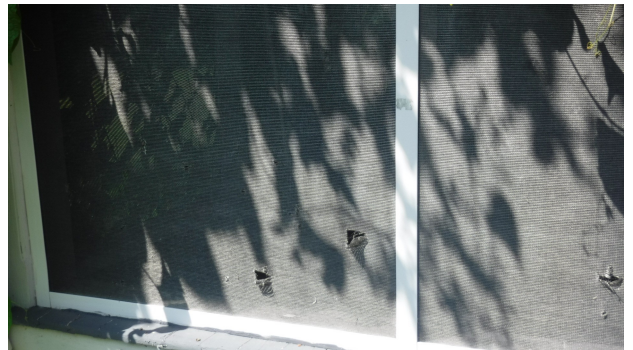
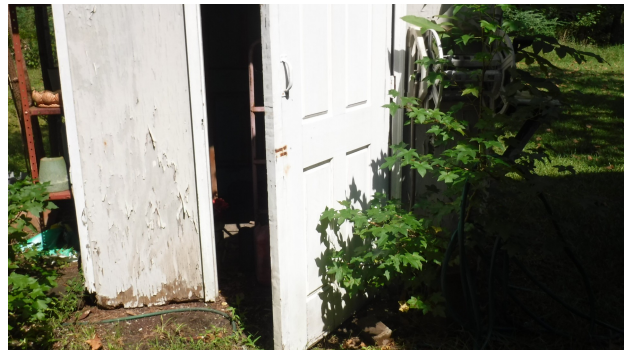
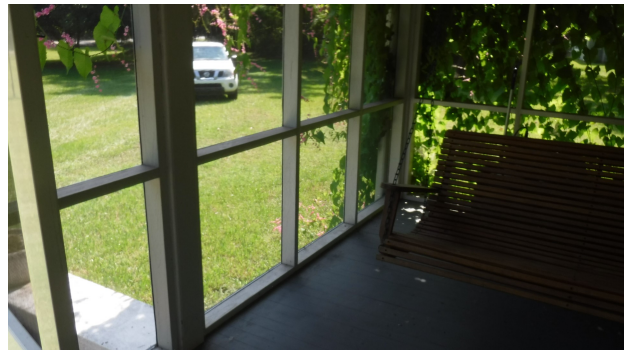
GROUNDS

Front/screened porch current builder suggest handrails/guard rails at porches over 30 inches off ground (no rails noted). Several screens torn at porch. Normal age-related type conditions. Back porch ceramic tiles can become very slippery when wet. If concerned suggest adding some nonslip adhesive as needed. Front porch brick steps mortar thin at areas. Suggest re pointing at some point. Wheelchair ramp at right side Areas of dry rot noted. Could pressure wash/ stain @ some point. Rear shed not accessible has been locked. Rear right building several areas of siding damages noted. Number of areas of detached building will need repairs. Several shed roof shingles are cracked/missing. Gas tank at right side of house. Suggest making certain tank converts with home.

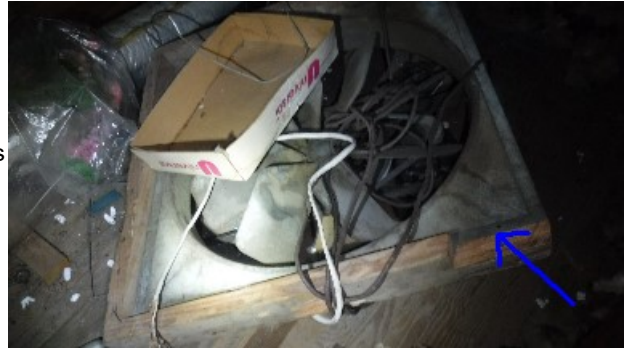
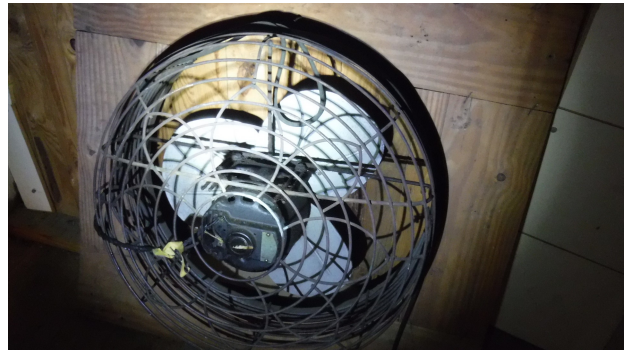
Roof Ventilation System

Minimal passive ventilation/ air flow noted due to Barn/ mansard roof configuration.

Gable end louvers noted. When inspecting attics noticed several power vent fans not in use.

Second floor will become increasingly warmer than first. If and when roof replaced suggest an additional box vents and/or power roof fans for better ventilation into the attic.

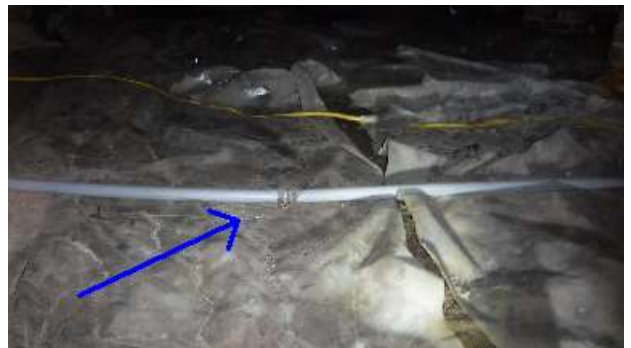
Interior Visible Water Pipes

Polybutylene piping systems are no longer installed due to leakage problems occurring at connections made with plastic fittings; these are copper fittings (copper fittings acceptable/ plastic are not) . Plumbing should be raised off crawlspace floor at several areas throughout crawlspace.

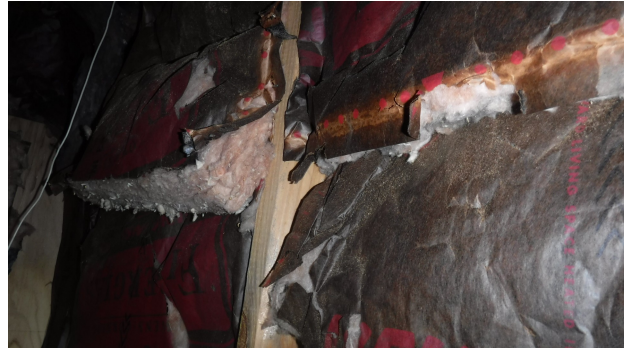
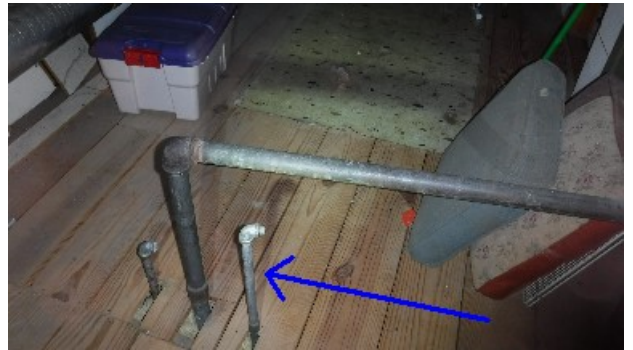
ATTIC

See roofing section on attic repairs suggested.
Insulation place backwards at right side attic. Should be paper side towards living space. This this way a long time. Several pipes at right side can be trip hazard.
Upper main attic is not accessible. On a mansard type roof generally would not have much space between the ceiling and roof.
This type of roof gives a good bit more headroom space.

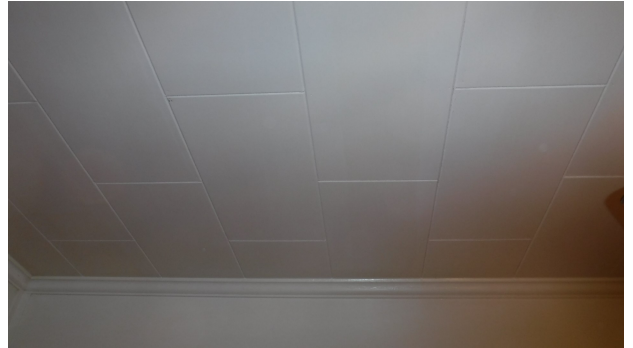
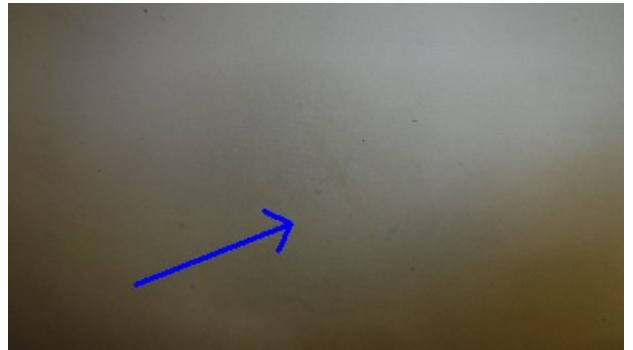
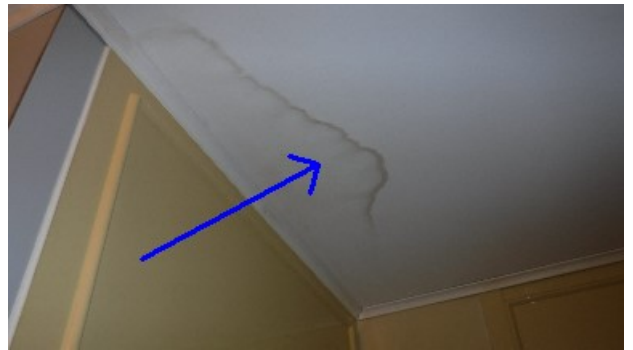
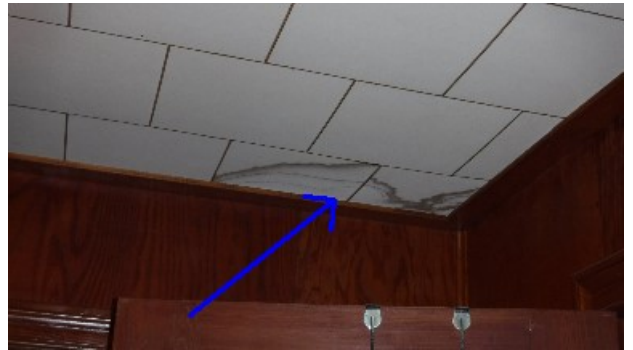
Interior Ceilings

Ceilings appear to be asbestos material. Generally if asbestos is air born is when it becomes an issue. Would need to have tested be 100% certain this is asbestos. Moisture stains noted at left side rear mid ceiling (areas patched), upper left bedroom.

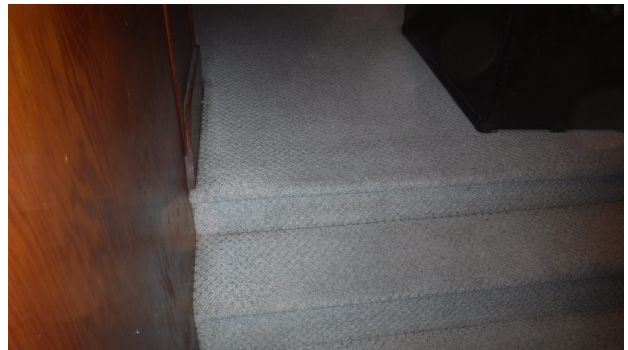
Stairways

Less than 6' 8" of headroom clearance at the lower stairwell ceiling & upper rear hall (no handrails @ upper hall steps). Headroom clearance does not meet current builder specifications. Normal age related conditions. If concerned suggest further evaluations, repairs as needed.
