A CLOSER LOOK INSPECTIONS, LLC
112 Tranquil Lane
Ladson SC 29456
(843)607-8486
acloserlookinspections1@gmail.com

Client Information: Record Number 3678

Sample 2, S
Sample
Sample , SC

Inspected 8/17/22 1:00 PM

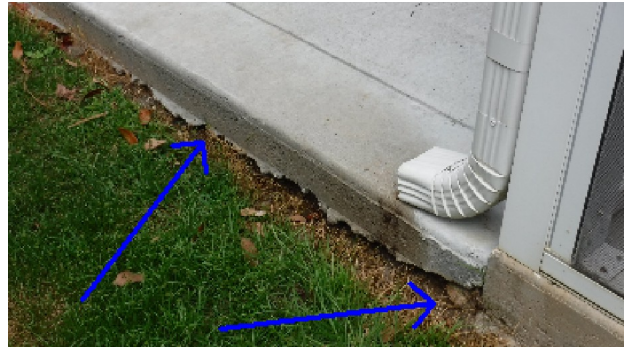
Patio

Gaps where concrete added patio meets ground (small area washed away). Suggest adding back fill soil & compacting.

Gaps where concrete added patio meets ground (small area washed away). Suggest adding back fill soil & compacting.

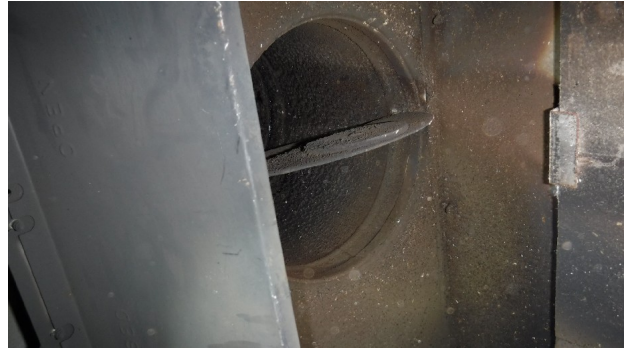
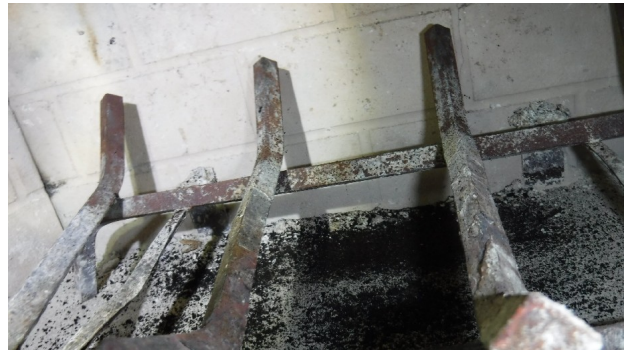
CHIMNEY

Soot noted in chimney; suggest cleaning prior to usage. Normal age related conditions/ overall decent condition.

Recommend a professional chimney expert evaluate this chimney system & make repairs as needed.

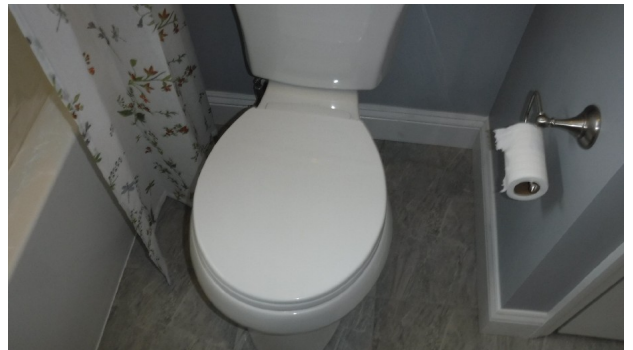
BATHROOM

Hall bath- toilet loose at flooring; suggest replacing wax seals and tightening.

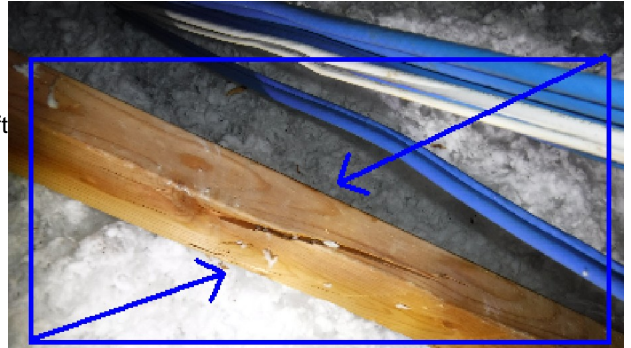
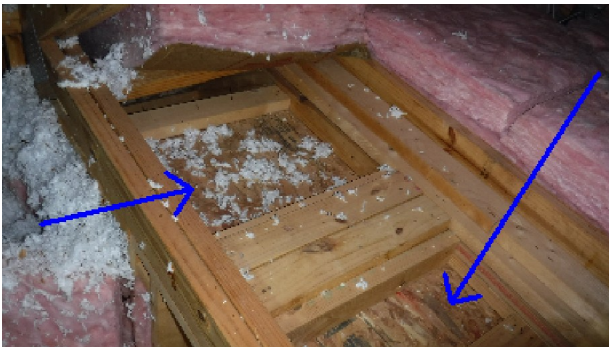
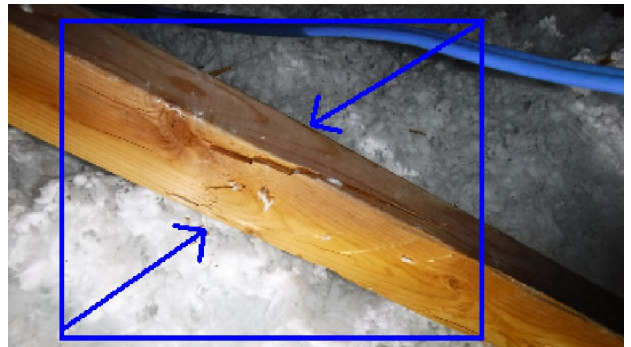
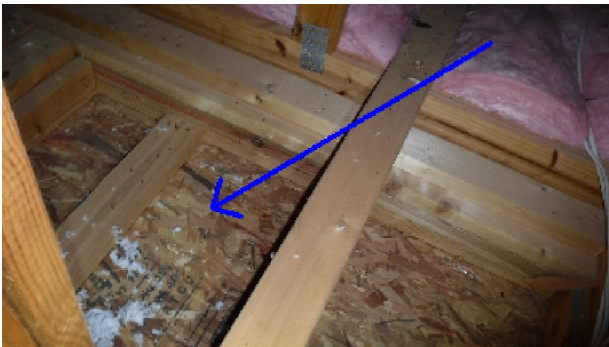
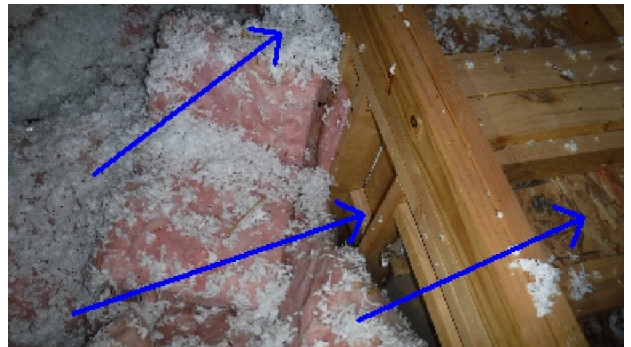
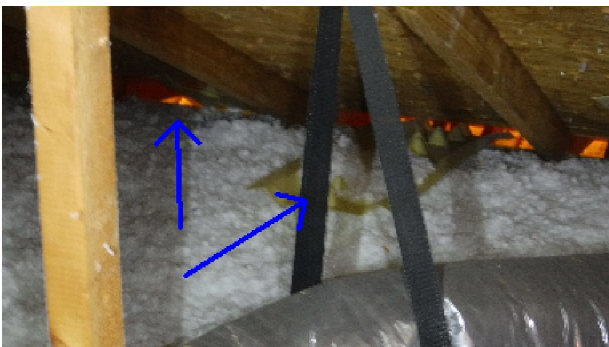
ATTIC

Rear right mid web cord on truss is fractured/ cracked. Suggest adding supports/ repairs to ad to rigidity.
 Baffles should be put back in place/ re secured above the insulation between rafters/trusses "over soffit vents" in order to allow the soffit vents to properly function (several areas of the rear mid, right, mid left front).
 Baffles push insulation down at soffit vents for proper air flow into attic.
 Suggest re hanging insulation @ several walls rear stairwell, room over the garage (few areas of insulation should be added @ rear room over garage over OSB boards).
 We recommend adding an attic vent fan to add to the roof life & help lower AC bills.
 Could ad a scuttle hole door @ right side room over garage to more easily access attic. Could possibly add flooring for more storage.
 Recommend a licensed professional evaluate these areas, any other areas of concern & make repairs as needed.

Rear right mid web cord on truss is fractured/ cracked. Suggest adding supports/ repairs to add to rigidity.
 Baffles should be put back in place/ re secured above the insulation between rafters/trusses "over soffit vents" in order to allow the soffit vents to properly function (several areas of the rear mid, right, mid left front).
 Baffles push insulation down at soffit vents for proper air flow into attic.
 Suggest re hanging insulation @ several walls rear stairwell, room over the garage (few areas of insulation should be added @ rear room over garage over OSB boards).
 We recommend adding an attic vent fan to add to the roof life & help lower AC bills.
 Could add a scuttle hole door @ right side room over garage to more easily access attic. Could possibly add flooring for more storage.
 Recommend a licensed professional evaluate these areas, any other areas of concern & make repairs as needed.

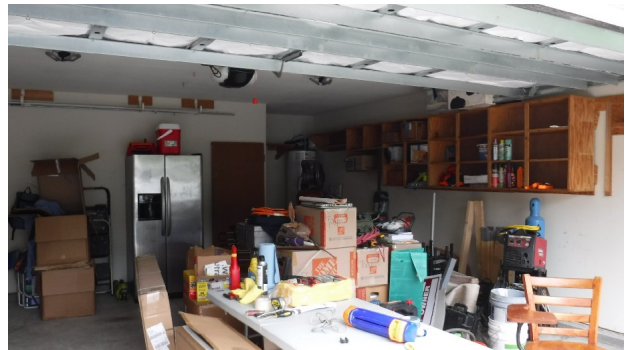
GARAGE

Stuff in garage makes areas inaccessible.

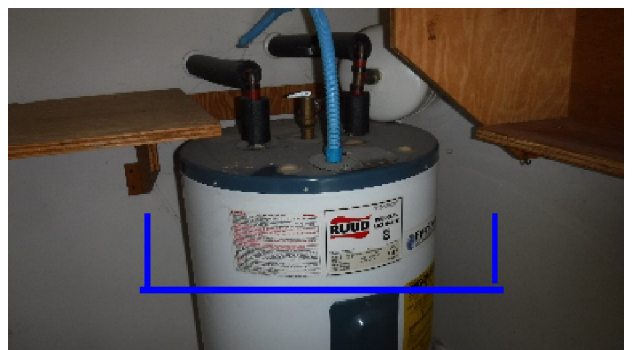
WATER HEATER

General Comment
Water heater is working properly at this time.
Suggest adding metal seismic hurricane strapping to connect the units to walls @ some point.

Suggest adding metal seismic hurricane strapping to connect the units to walls @ some point.

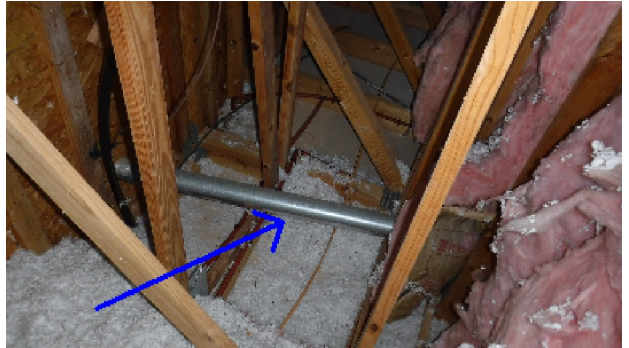
Dryer Vented

We recommend having the dryer vent cleaned "every 2-3 yrs" to help dissipate heat & make the dryer run more efficiently.

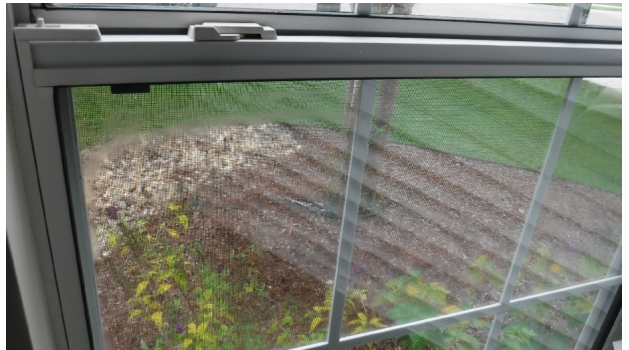
Window Character Type

Several screens are missing and torn.

Window tint at several windows master bedroom/ closet "areas of tint have come off in closet @ windows".

Cannot be 100% certain glass is condensated at few windows until cleaned; do not think they are. If condensation is present appears to be minimal.

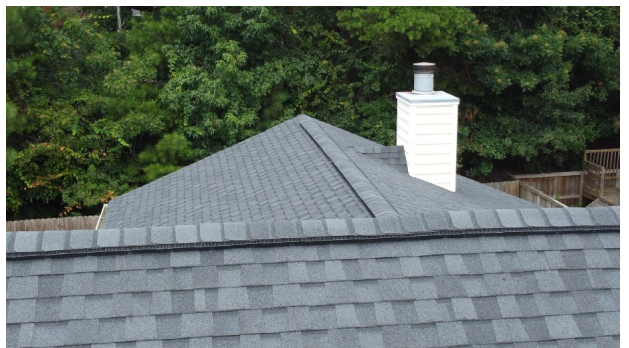
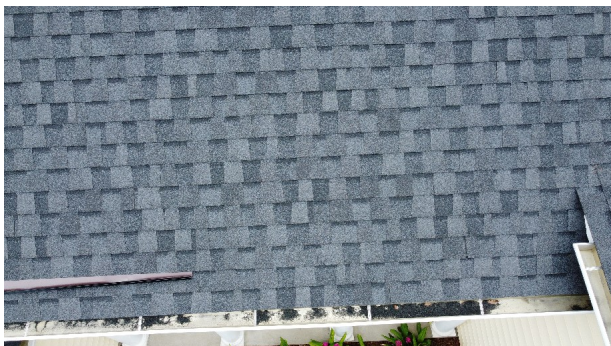
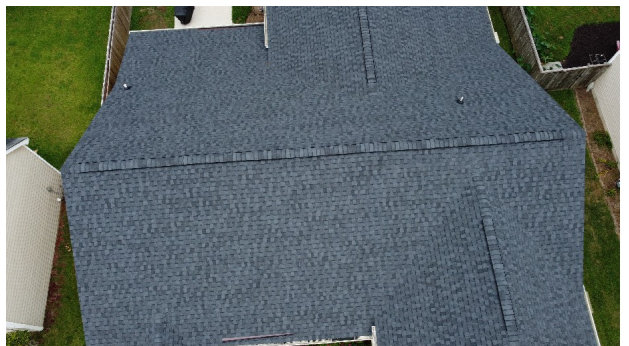
ROOF

Roof has recently been replaced with a 25-30 year architectural shingle.

Normal wear noted. No visible roof leaks at the time of the inspection to visible conditions.

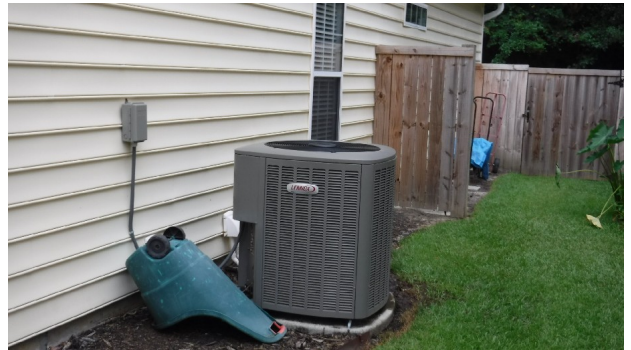
COOLING SYSTEM

HVAC unit is pushing cool air at this time. Operating properly at this time. Suggest having serviced yearly.

HVAC units have been replaced 2018. See if any warranty information associated with units.

Zone thermostat controls- 1 upstairs & 1 downstairs.

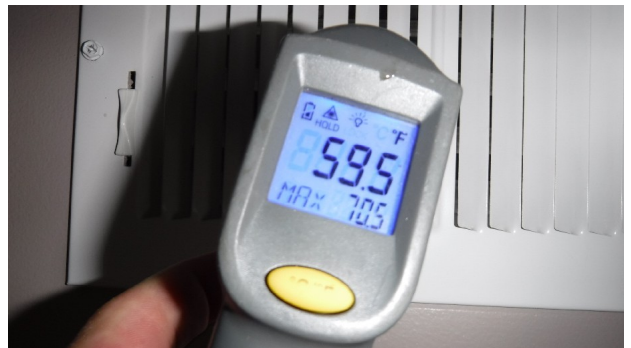
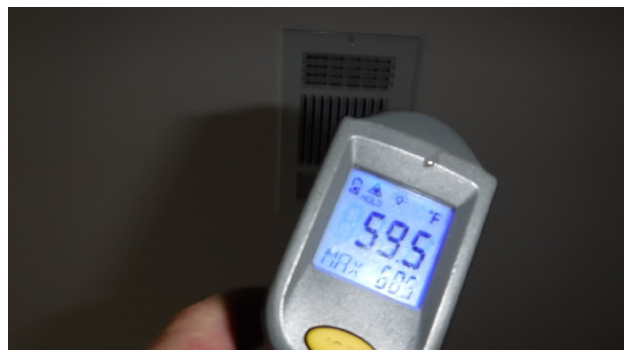
Differential Temp 1

Return temp = 78 Supply temp = 58 Differential Temp = 19
Unit is pushing cool air at this time, suggest servicing yearly.

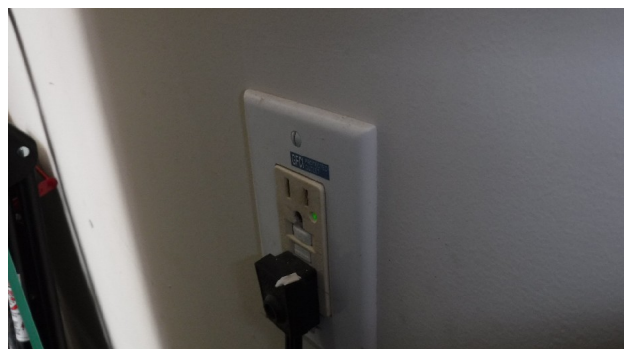
Garage Electrical System

Exterior GFCI reset in garage behind refrigerator (back wall).

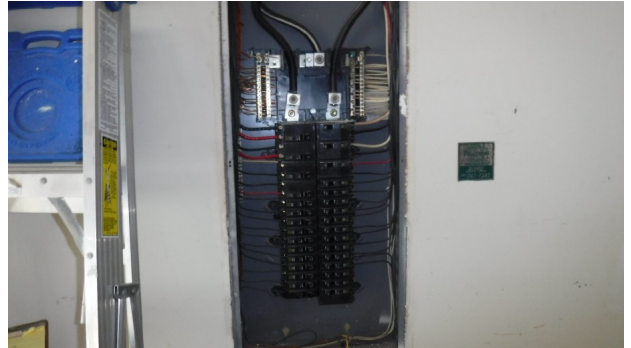
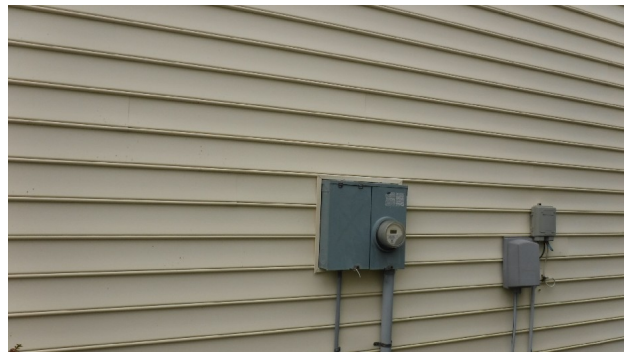
ELECTRICAL SYSTEM

200 amp under ground service noted. Minimal/ no electrical defects noted to conditions observed.

Picture of panel box with cover removed.

Main shutoff at the exterior service entry.

FYI- Main shutoff at the exterior service entry meter. Would need to shut each breaker off individually in the panel box in the garage or shut off main breaker exterior meter to turn all power off. Certain jurisdictions require electrical main shut off at exterior meter; normal building practices in this jurisdiction.

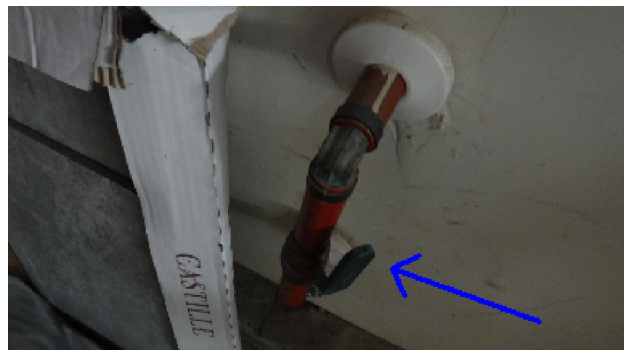
Main Water Shut Off

Shutoff right side garage wall.

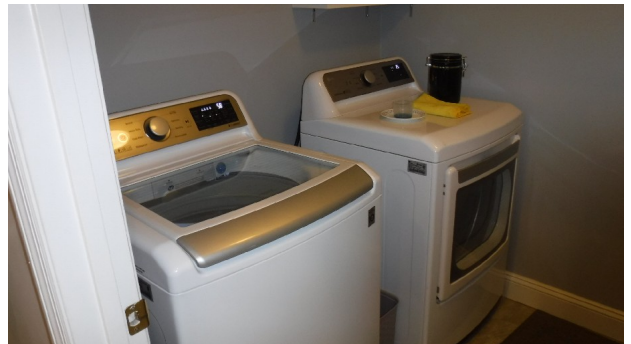
LAUNDRY

Washer & dryer are operational at this time.

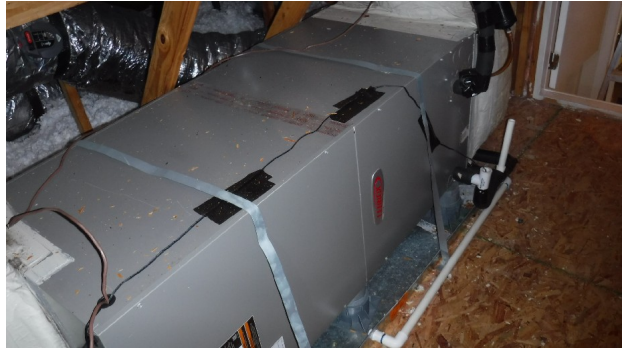
FURNACE

Heat not tested; exterior temperatures are too warm & could damage the unit.

Pictures of units in attic.

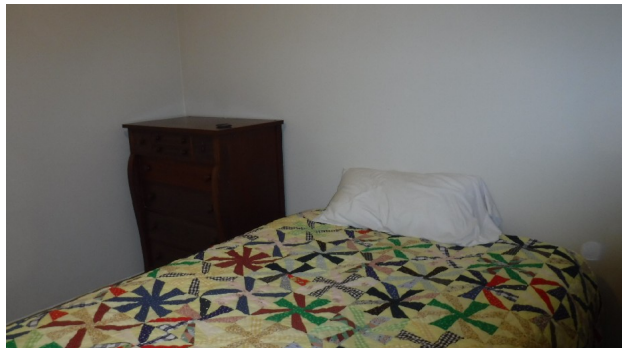
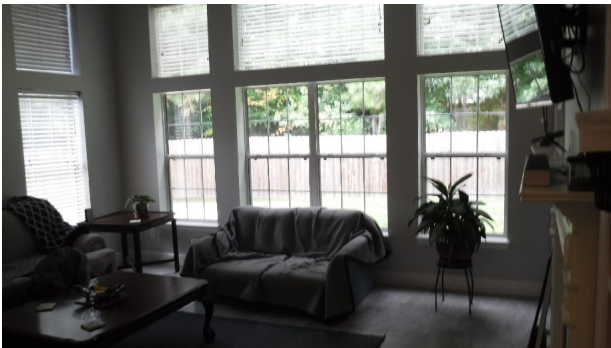
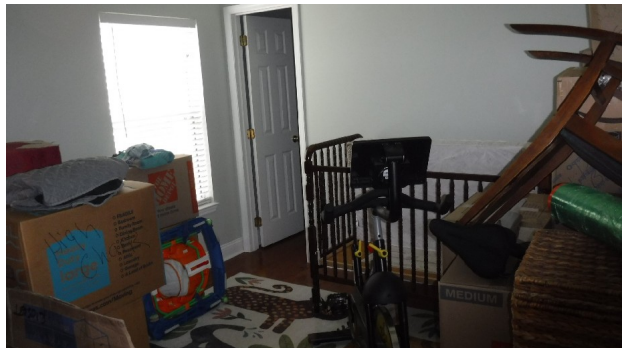
Have included several other pictures of interiors. Interiors in decent condition.

Have included several other pictures of interiors. Interiors in decent condition.
