Inspected 9/20/22 1:30 PM

Inspection Summary

A CLOSER LOOK INSPECTIONS, LLC

Record 3719 - Sample, S Sample, Sample, SC

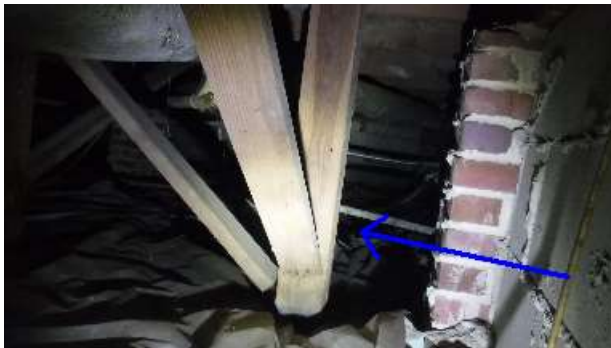
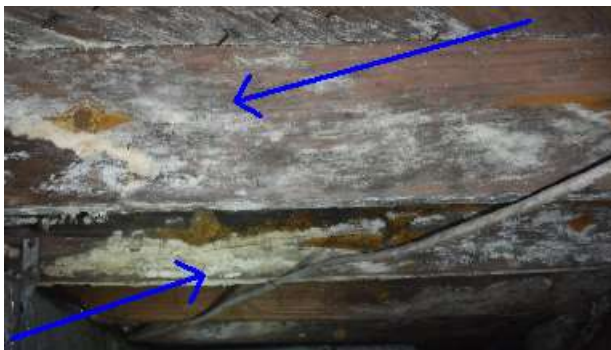
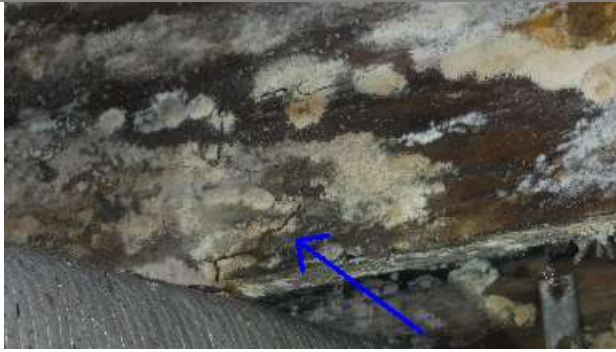
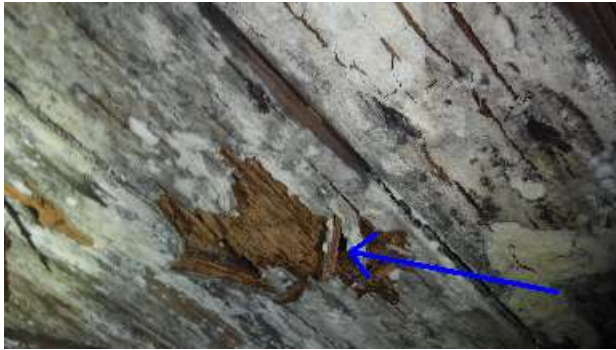
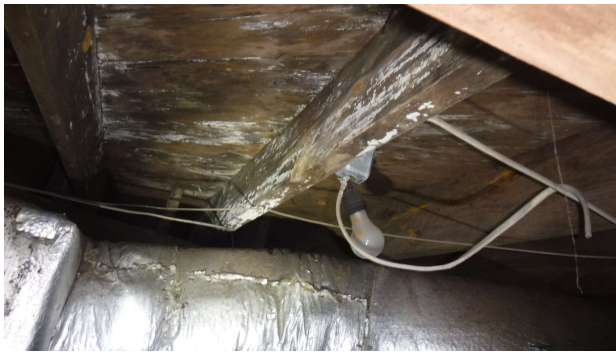
Middle girder beams (under the living room; settlement issues noted at flooring in this room) compression noted on top of piers. Girders are bowed/warped (possibly cracked) on top of these piers. Right side mid several bricks missing @ piers. Right side mid cracked more joists noted. Sister joists, additional supports needed. Cubicle Brown dry rot noted at mid crawl from elevated moisture coming off ductwork. Several areas of repairs have been completed under kitchen and areas.

Cut joist under the bath, suggest additional supports. Right side under kitchen additional supports of been added. 6 x 6 pressure-treated piers. Suggest replacing with possibly concrete piers and supports at some point

Some mortar is thin/ missing @ brick piers; suggest adding as needed.

Moisture stains under baths, kitchens (some repairs made under kitchen). Mildew, elevated moisture levels fungi, potential mold under mid flooring system (cannot determine unless tested on flooring system throughout). Suggest spraying with fungi/ Bora Clean. Often Termite companies will off this service.

Suggest sealing crawlspace vents to keep rodents out of crawl. Debris in crawl should be removed.

See CL100 remarks. Recommend a licensed contractor evaluate these areas, the entire crawlspace & make repairs as needed prior to closing.

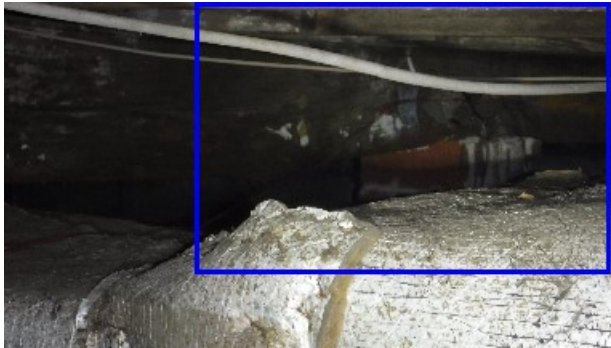
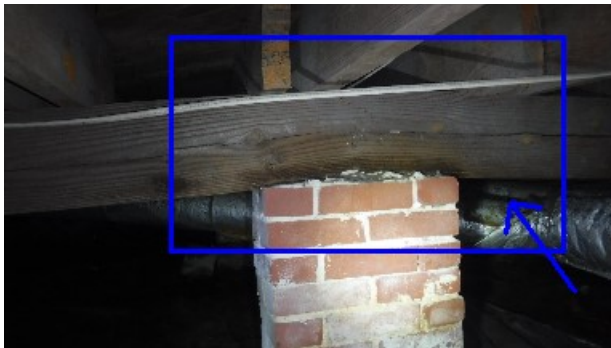
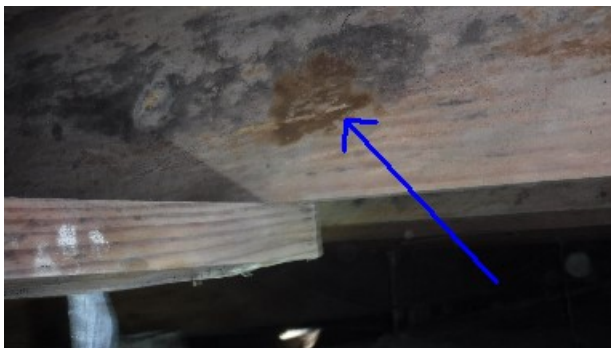
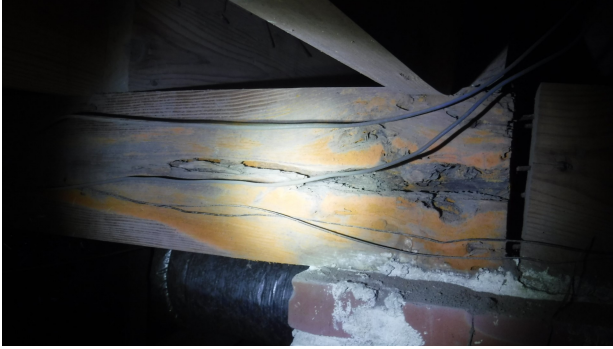
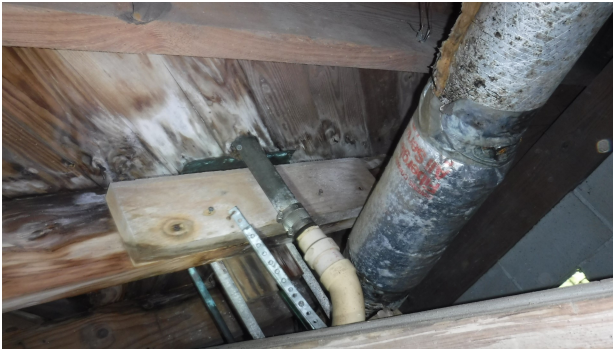
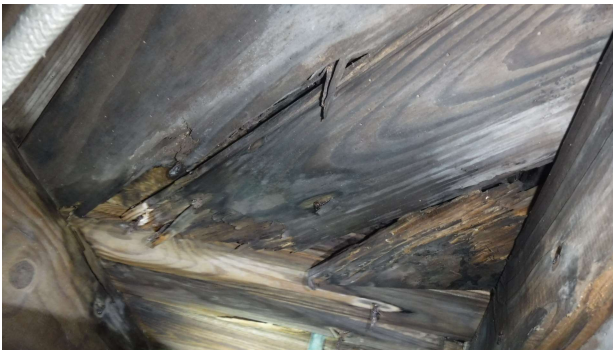
More crawlspace discrepancies / pictures as follows.

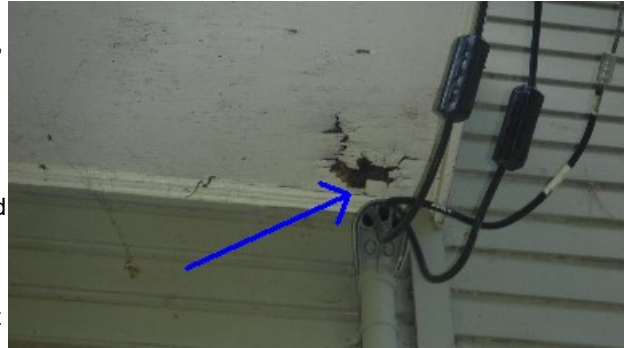
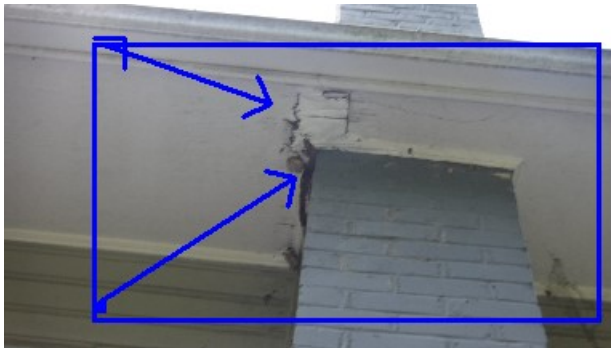
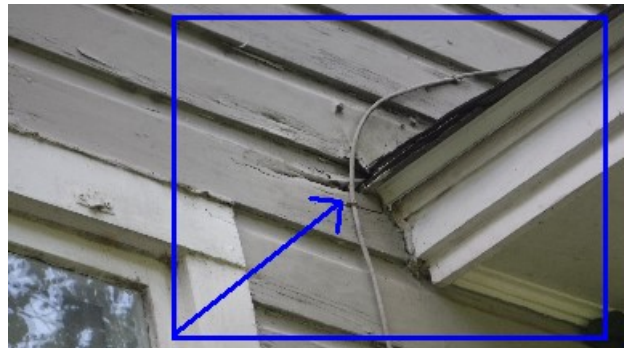
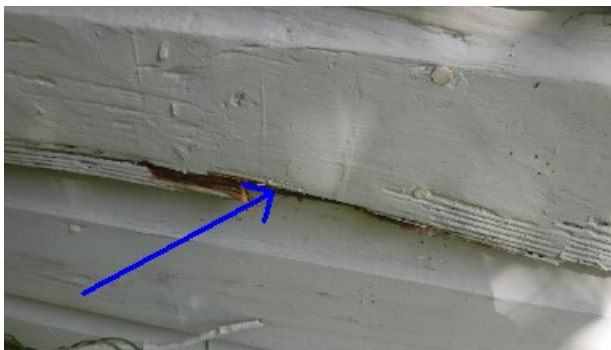
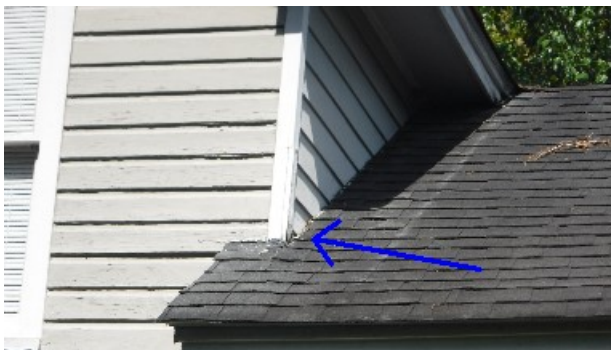
Exteriors have been painted making wood damages more difficult to spot. See CL 100 remarks. Suggest all exteriors wood trim "windows, soffit's/ fascia" be evaluated/ repairs made as needed by qualified contractors. Wood damages appear to be normal age-related type conditions. Exterior wood will require ongoing maintenance. For the age of this house very normal conditions. Wood damages to include, but not limited too: right side rear soffit corner, rear right upper where roof ties in to siding, upper right toward Gable where siding meets roof, right side front porch corner outer under gutter, left side mid "front behind bush", left side rear above window & areas. Paint is chipped/ peeling at few areas. Most likely/ good chance paint is lead based paint. Should not be ingested by children or pets. Trees & shrubs should be cut away from the home as needed. Should be roughly 8"-12" between siding & home.

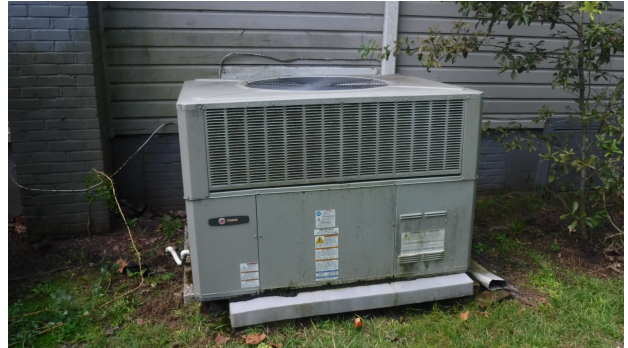
Differential Temp 1

Temperature differentials are low on the AC cooling. Recommend service, evaluation & freon charge prior to closing. Recommend evaluation/ repairs as needed by a licensed HVAC professional prior to closing.

Return temp = 80 Supply temp = 73-75 Differential Temp = 7-5

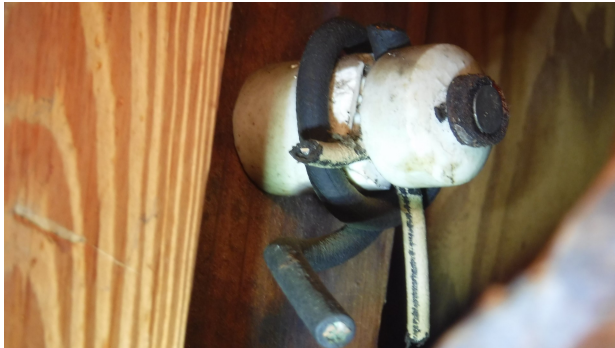
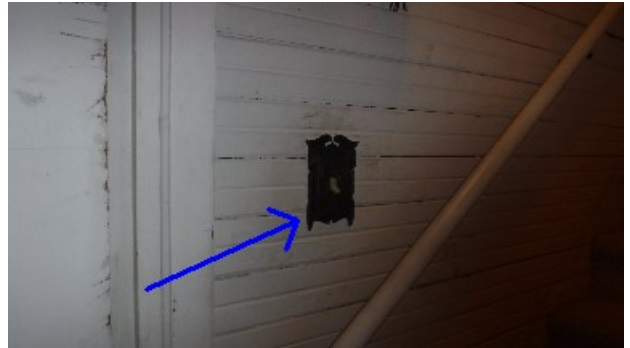
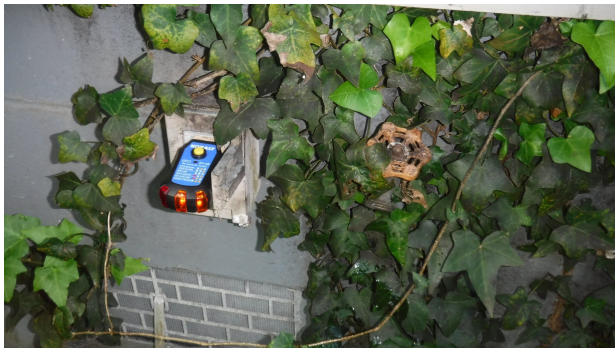
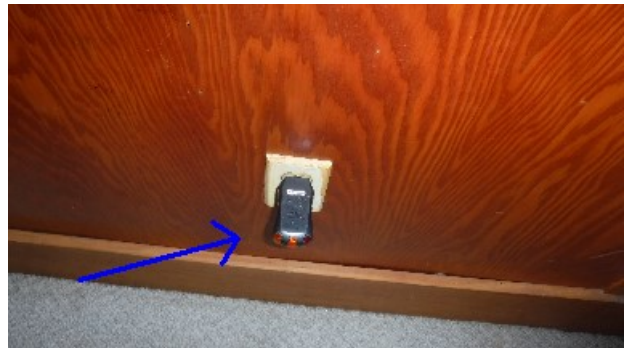
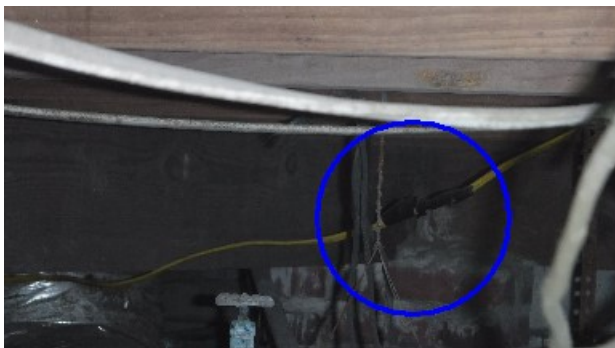
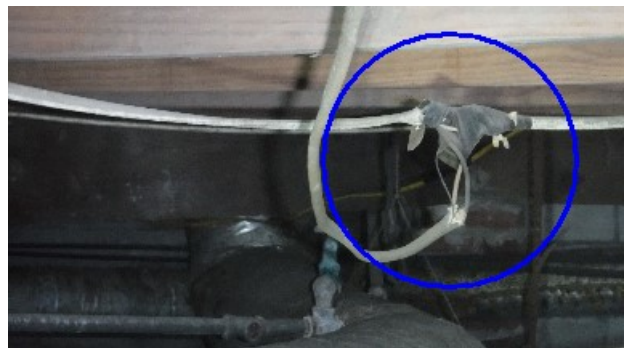
More pictures of electrical defects continued.

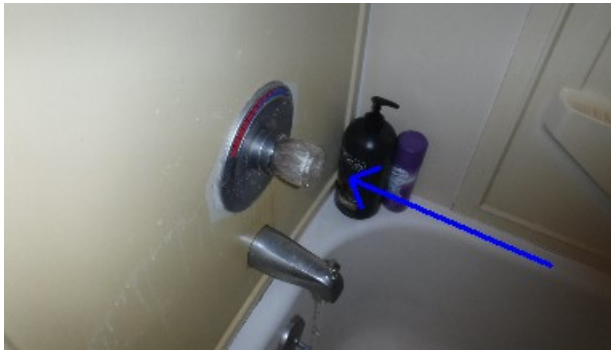
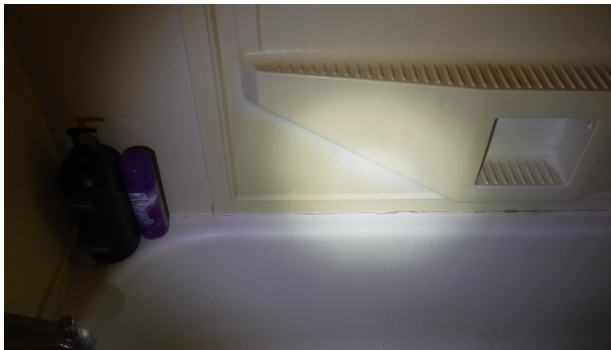
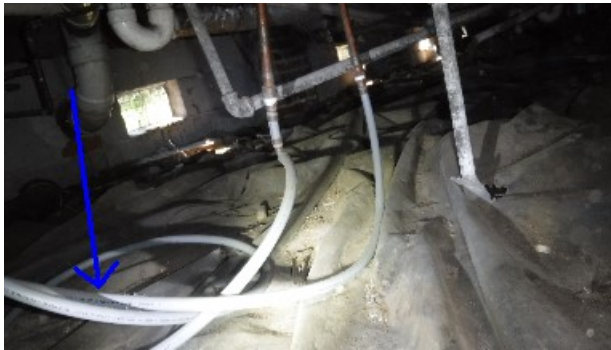
PLUMBING

Suggest running washing machine waterlines behind walls. Suggest raising plumbing off ground in crawlspace. Master bedroom toilet runs. Suggest replacing flapper hardware. Upper hall bath toilet is loose at ground. Suggest replacing wax seals. Gas water heater is not properly vented. Vent flues in close proximity to windows. Suggest properly venting gas water heater appliance. Shower faucet control is stripped. Upper bathtub rust/corrosion noted. Suggest properly caulking, sealing shower and tub surrounds. We recommend a licensed professional evaluate "ALL" plumbing & make repairs as needed.

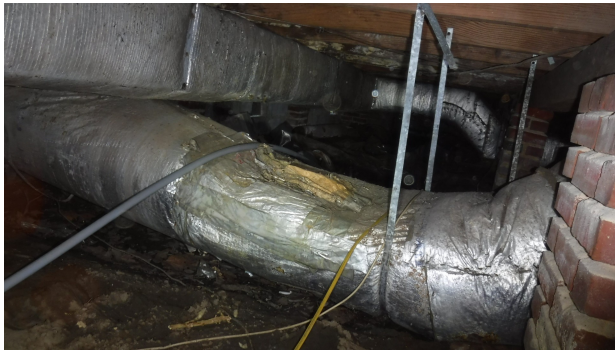
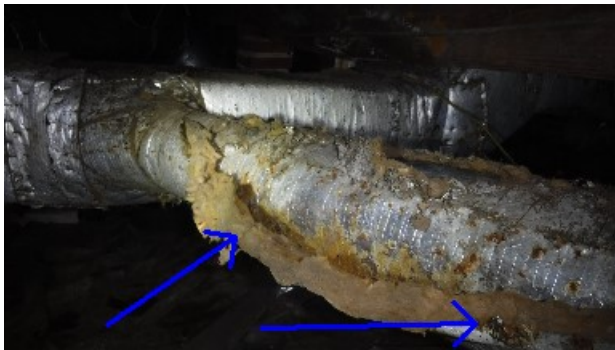
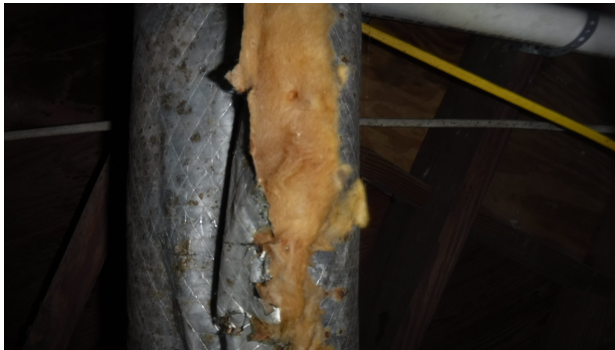
Distribution System Material

Sections of ductwork are poorly sealed, torn ductwork & should be resealed as needed in the crawlspace & attic's (right side attic mid ductwork mashed down). Several sections of ductwork may need to be replaced crawlspace due to rust and corrosion. Torn ductwork in the crawlspace has caused/ put a good amount of moisture into the flooring system.
Suggest evaluation at "ALL" ductwork & repairs made as needed prior to closing.

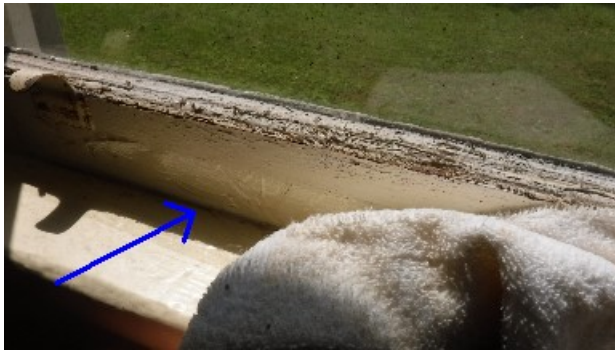
BATHROOM

See plumbing section on bath repairs.
Damaged flooring, elevated moisture levels under hall bath toilet.
Same bathroom window has been taped, towel added at lower sill.
Suggest making certain window properly sealed.
Slight chips noted at Hall bath tub. Suggest epoxy seal as needed.
Some cracked tiles, mortar thin @ areas of baths.

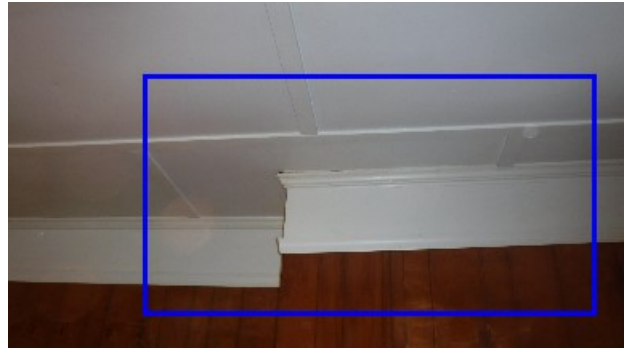
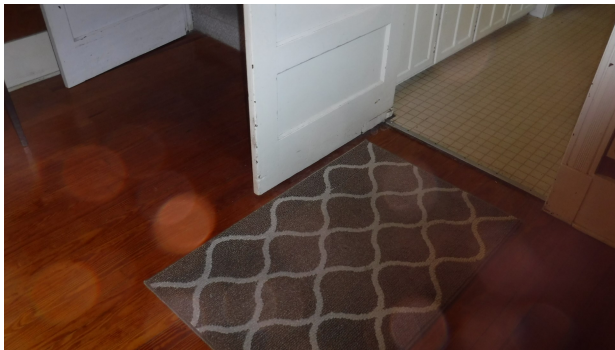
INTERIOR ROOMS

Flooring significantly dips/ settlement at living room, dining area. Appears to be from issues in crawlspace. Once these issues in crawl are addressed should take care of settlement.
Lead based paint more than likely at areas of trim throughout. Chips should not be ingested by children/pets. Suggest further evaluation, removal if concerned.
Carpets are stained at several areas throughout.

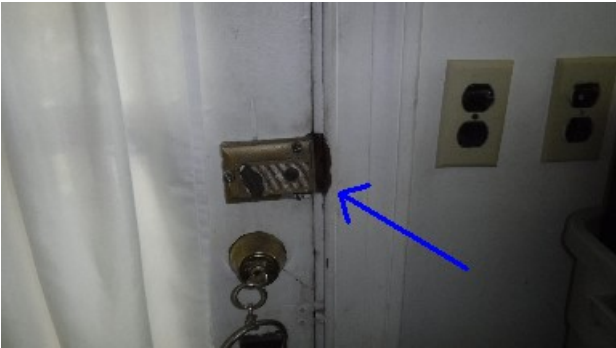
Entry Doors

Backdoor upper lock is missing hardware.

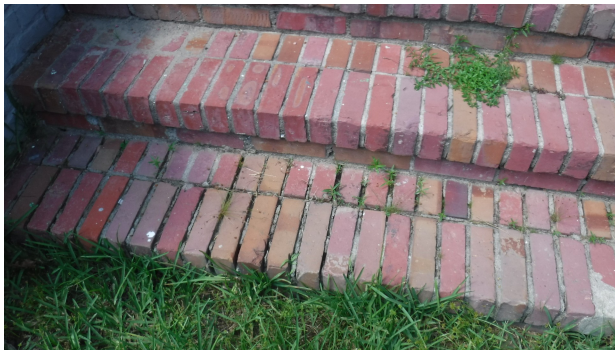
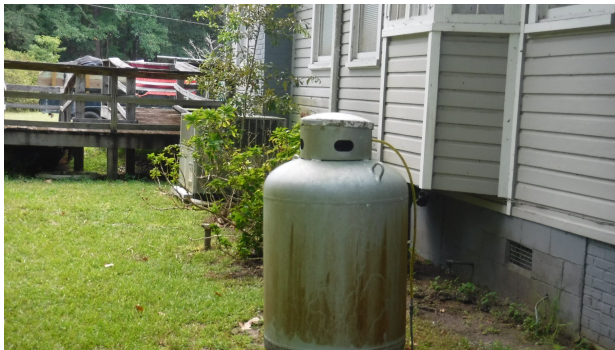
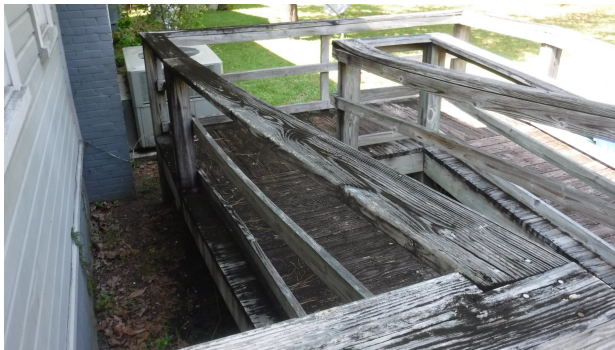
GROUNDS

Front/screened porch current builder suggest handrails/guard rails at porches over 30 inches off ground (no rails noted). Several screens torn at porch. Normal age-related type conditions. Back porch ceramic tiles can become very slippery when wet. If concerned suggest adding some nonslip adhesive as needed. Front porch brick steps mortar thin at areas. Suggest re pointing at some point. Wheelchair ramp at right side Areas of dry rot noted. Could pressure wash/ stain @ some point. Rear shed not accessible has been locked. Rear right building several areas of siding damages noted. Number of areas of detached building will need repairs. Several shed roof shingles are cracked/missing. Gas tank at right side of house. Suggest making certain tank converts with home.

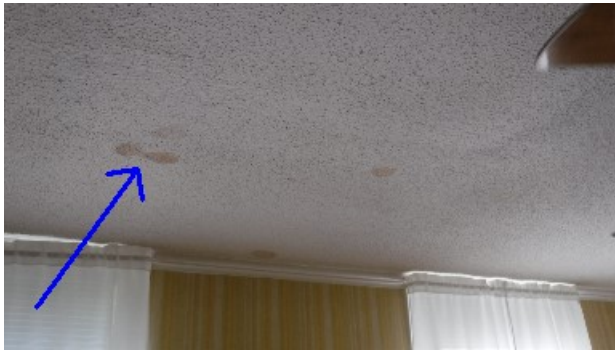
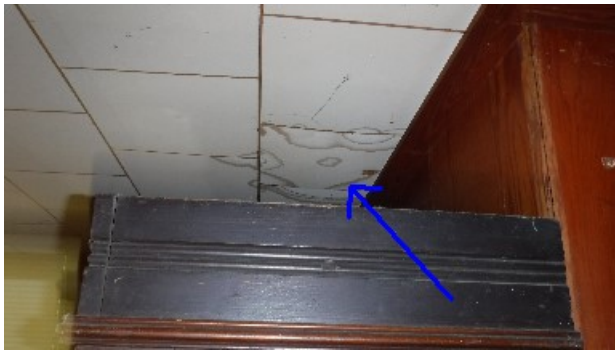
Interior Ceilings

Ceilings appear to be asbestos material. Generally if asbestos is air born is when it becomes an issue. Would need to have tested be 100% certain this is asbestos. Moisture stains noted at left side rear mid ceiling (areas patched), upper left bedroom.

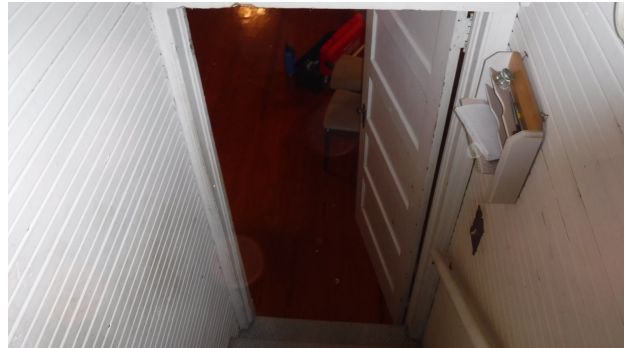
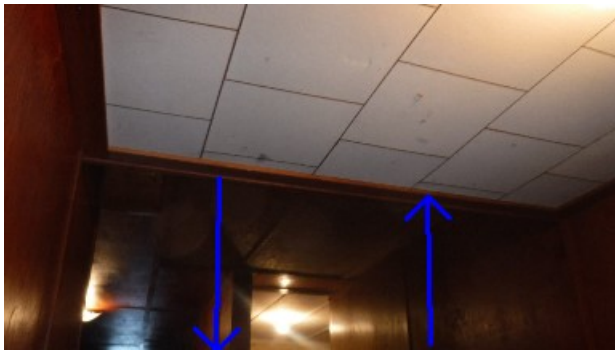
Stairways

Less than 6' 8" of headroom clearance at the lower stairwell ceiling & upper rear hall (no handrails @ upper hall steps). Headroom clearance does not meet current builder specifications. Normal age related conditions. If concerned suggest further evaluations, repairs as needed.

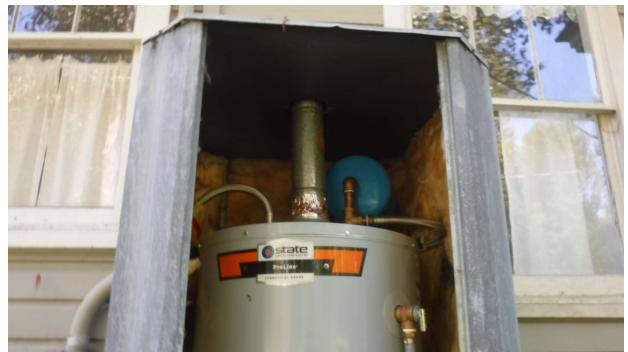
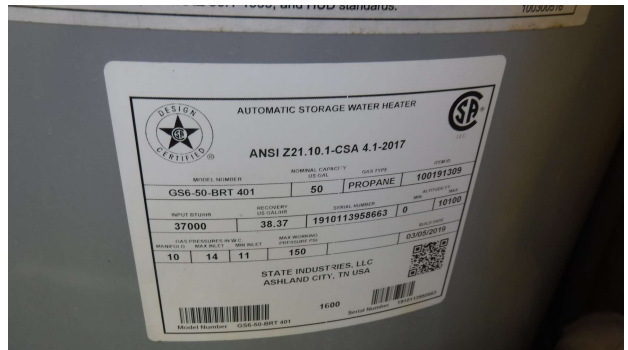
WATER HEATER

Water heater is working properly at this time. Suggest properly venting.
